Town Belmont
Historic District Commission
 Homer Municipal Building, 2nd Floor
 19 Moore Street
 Belmont, MA 02478

APPLICATION

Address of Property: 543 PLEASANT ST
 Property Owner's Name: S.V. KUMAR & K.K. BANGER (SHEETAL & KAL)
 Address: 543 PLEASANT ST, BELMONT MA 02478
 Email: SVK1928@YAHOO.COM, KKB-28@YAHOO.COM Phone: 202-304-7536

REPLACING ERODED / DECAYED / BROKEN UNSAFE WINDOWS & DOOR
 TO SECURE PROPERTY & MEET SAFETY.

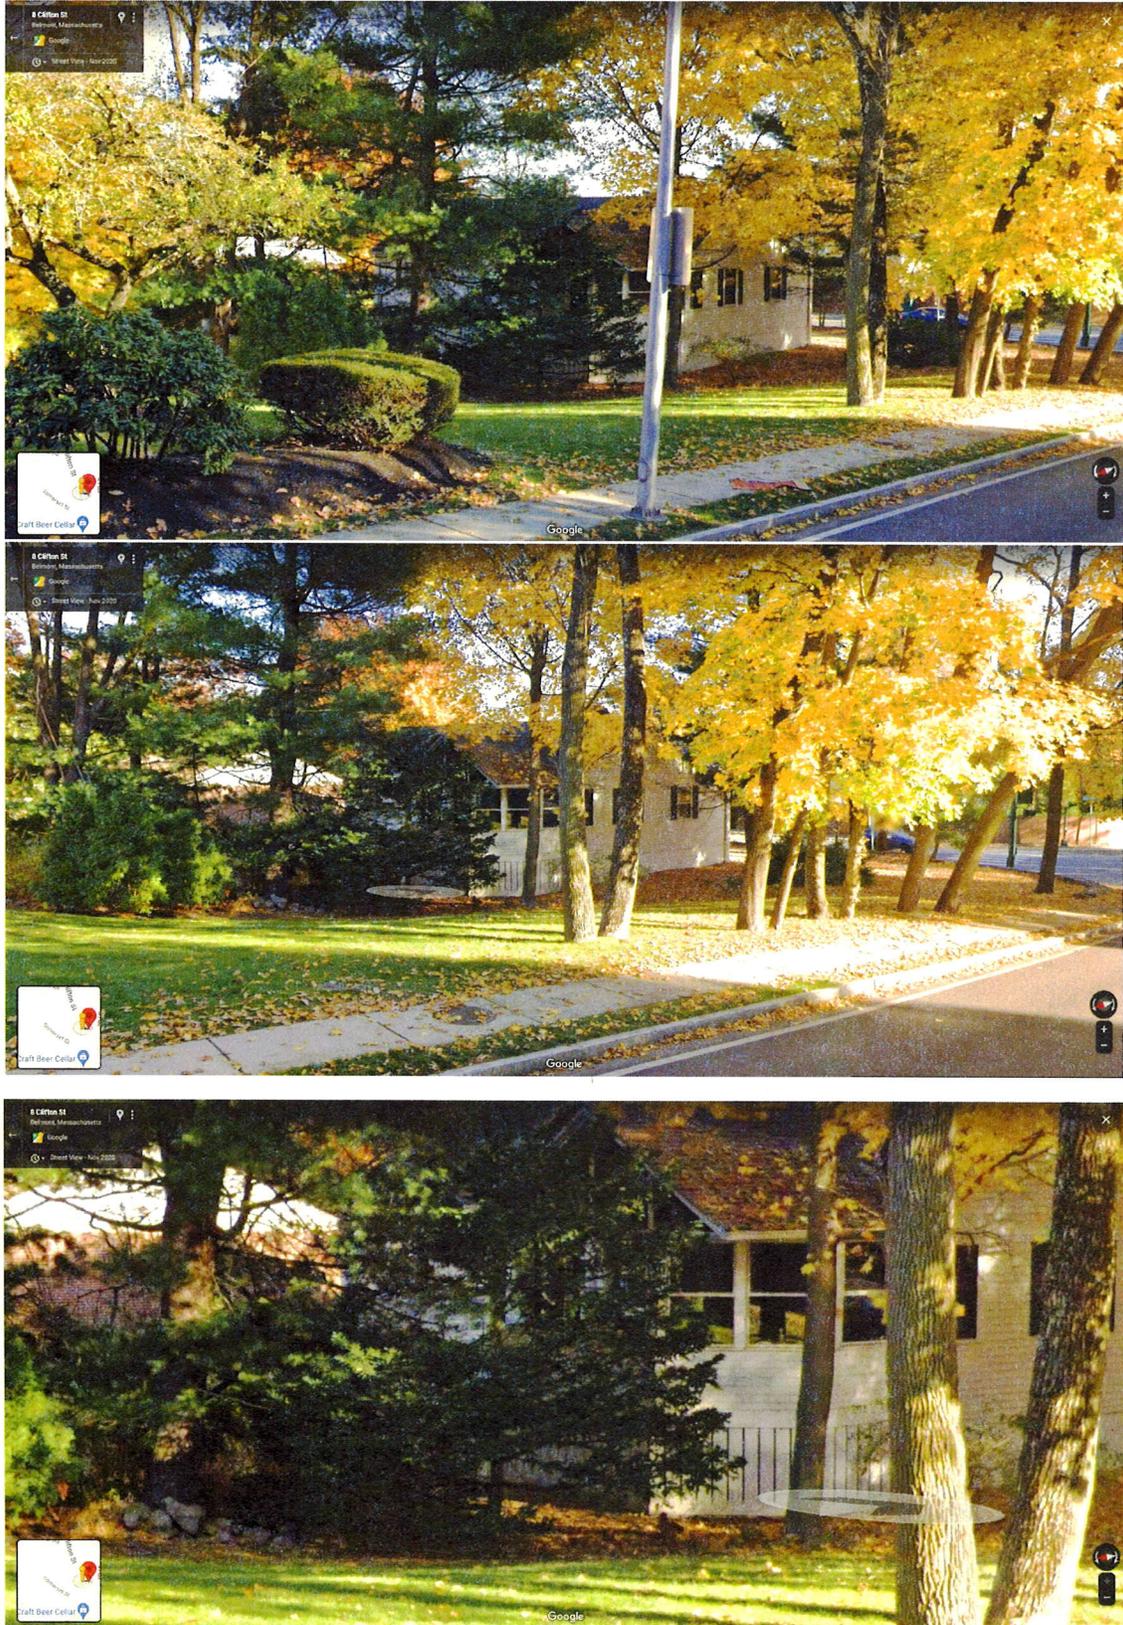
Figure c View from Clifton St, One basement window and basement door is not visible due to the patio and the enclosed porch structures.

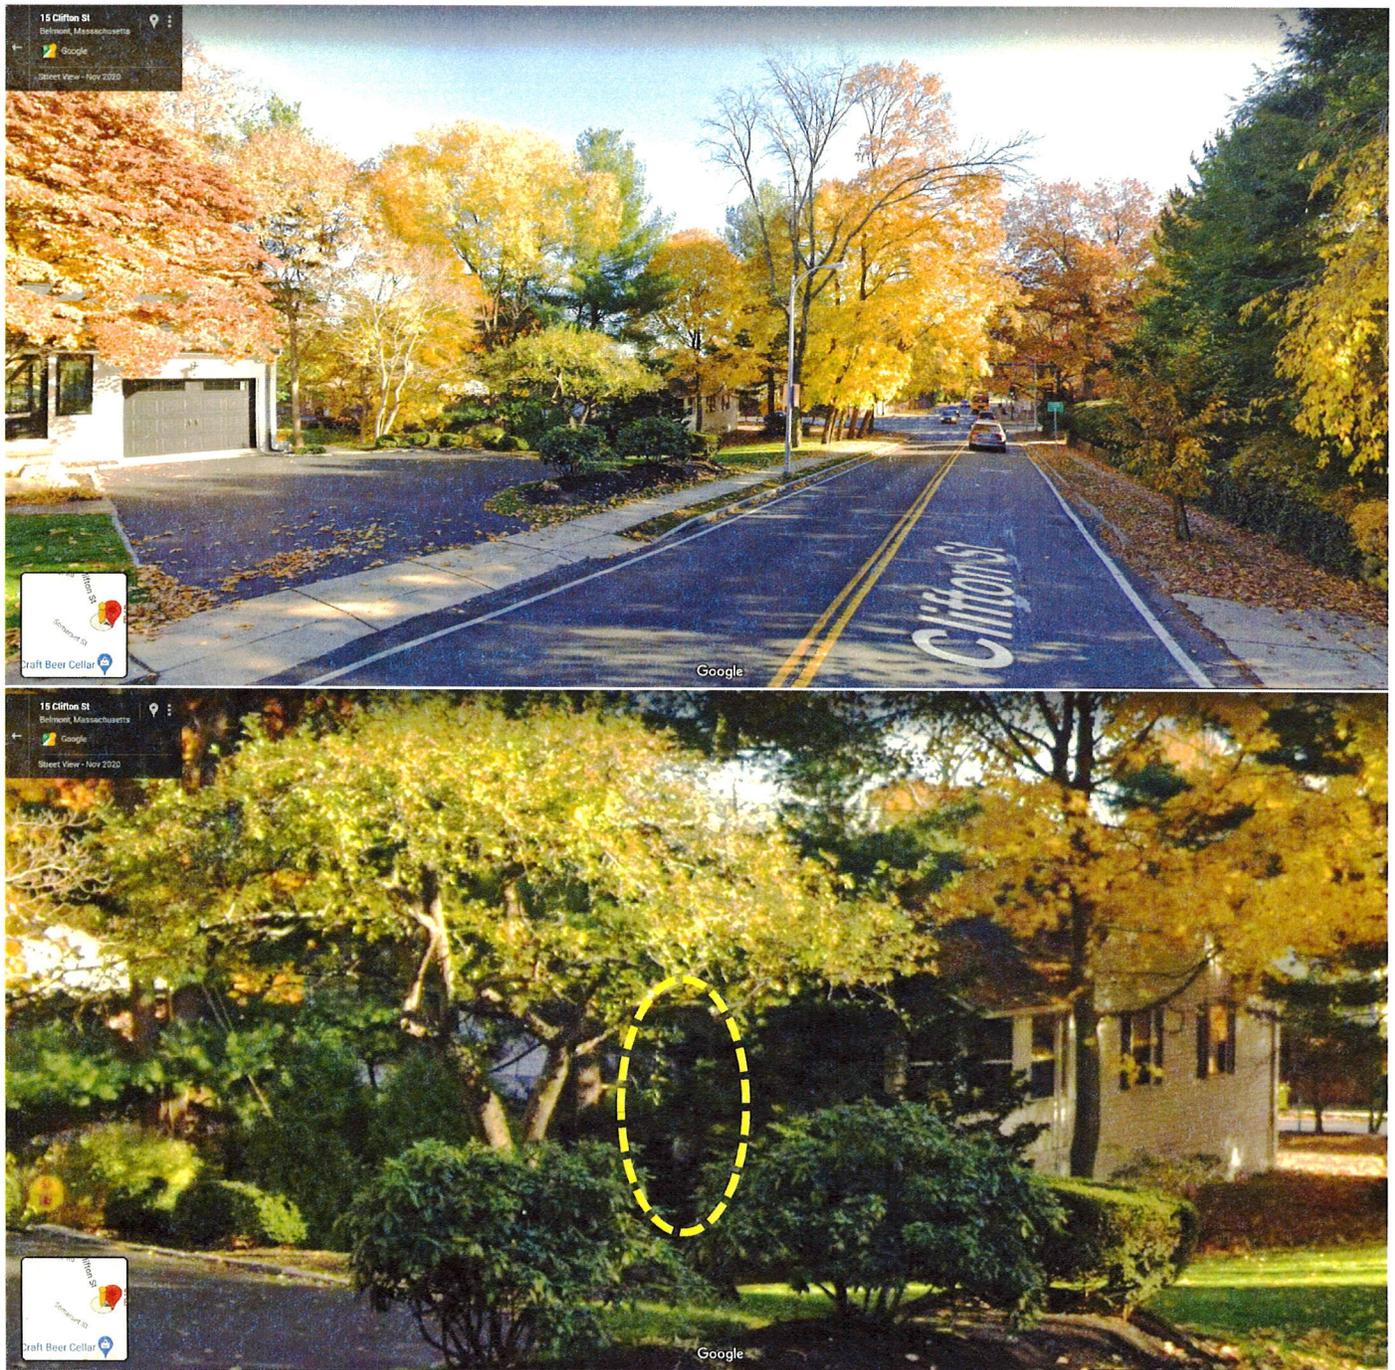
Figure d view standing by Clifton neighbor zoomed in. The basement door is hidden behind the Enclosed porch. The dotted circle shows where the door would be.

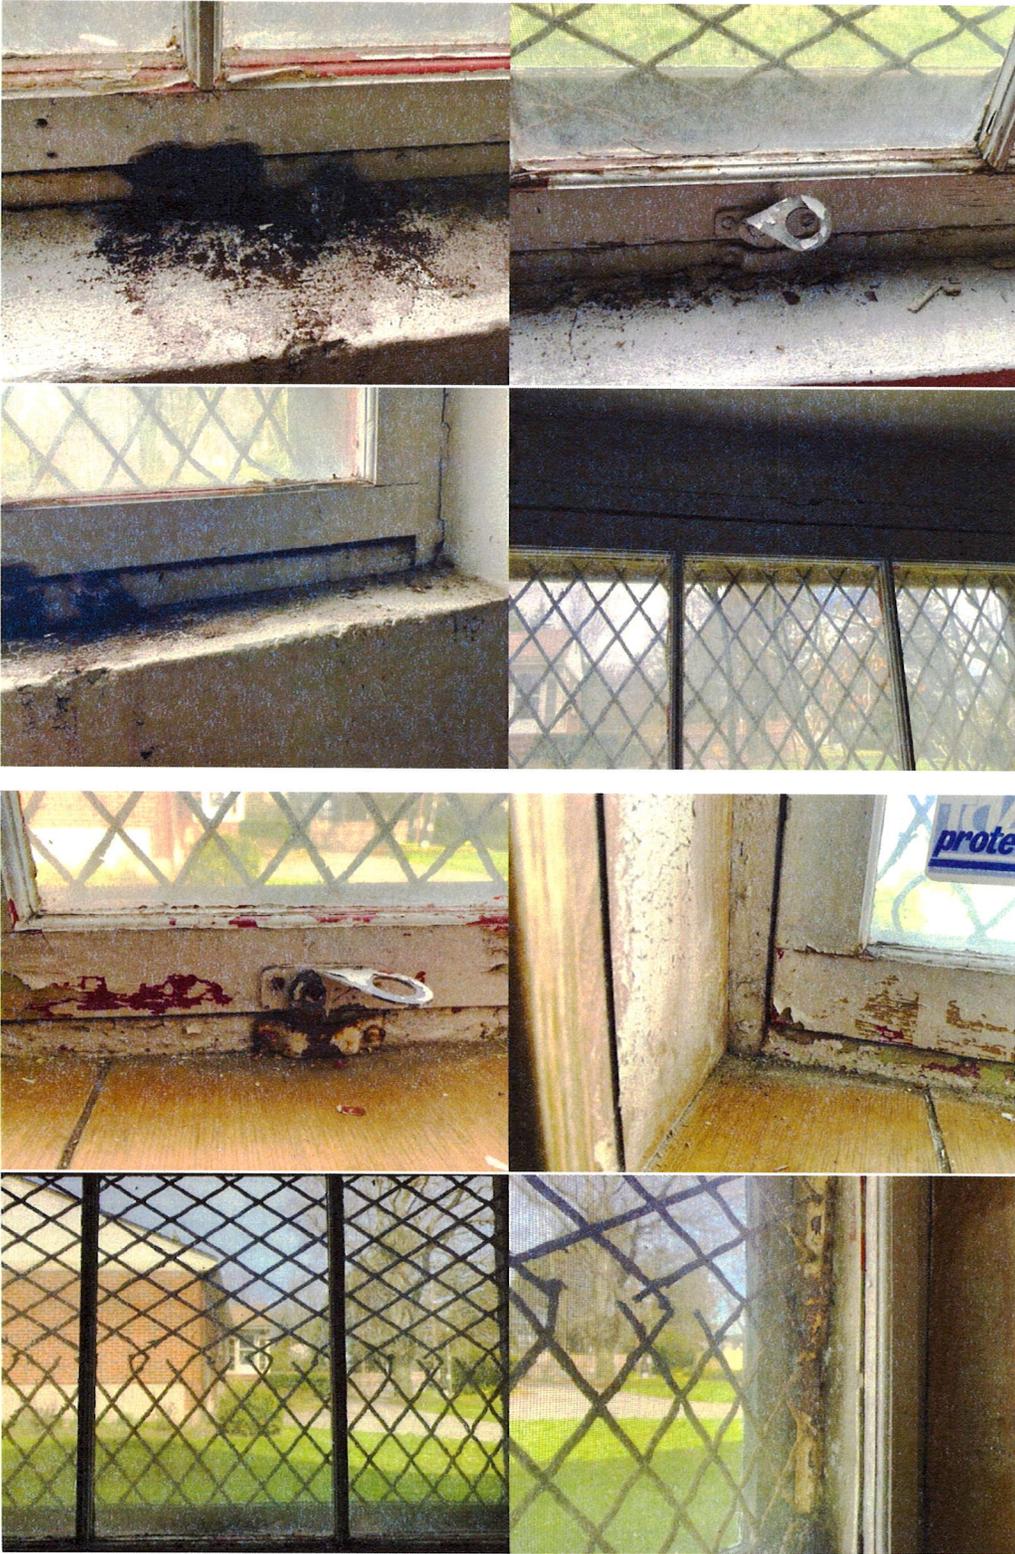
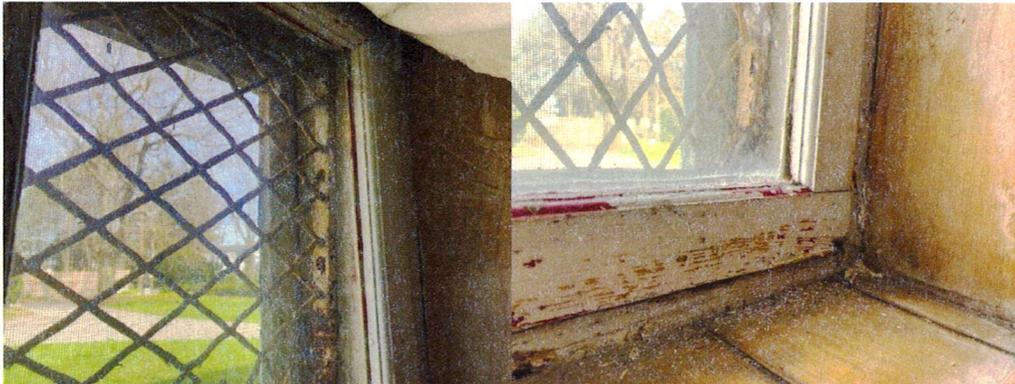
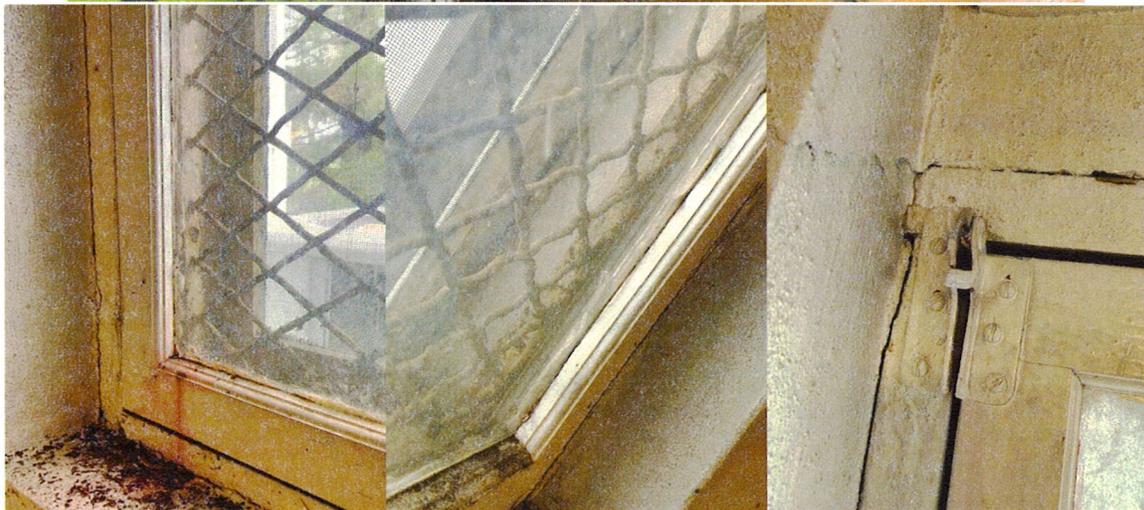
Black mold, metal decayed, wood rotten, frame at joints swollen due to water damage. Window, not fitting frames. Latches are not functioning for security.

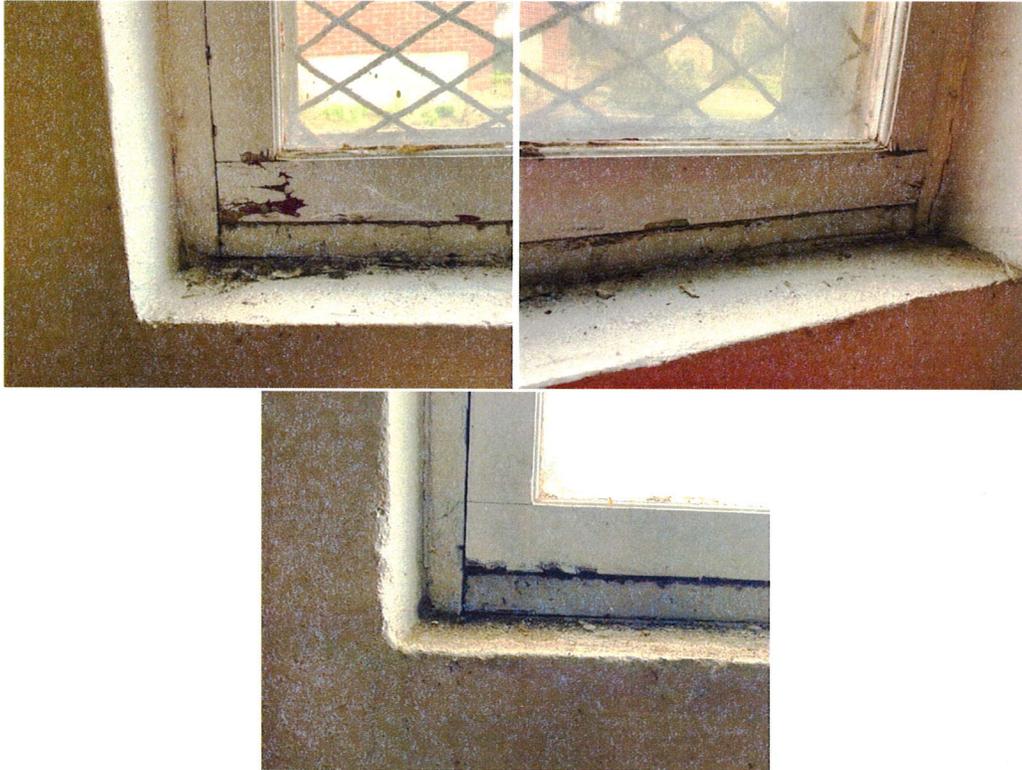
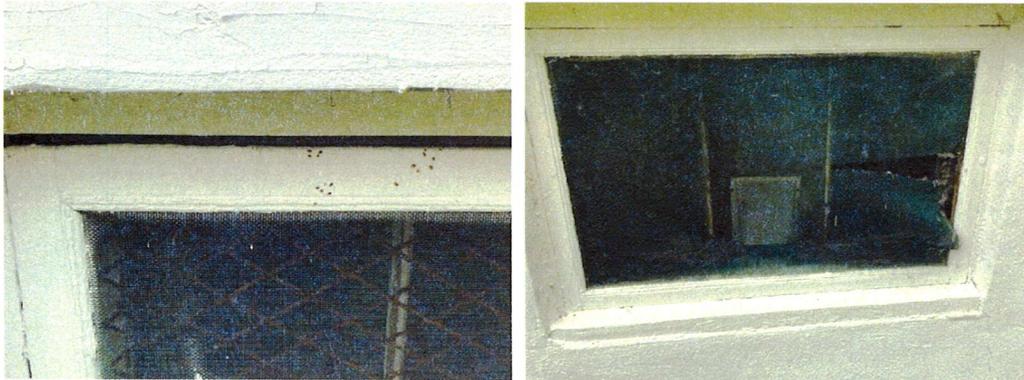
Framework separating at joints, window wood expansion/rot, ill-fitting and not closing correctly or opening at all, hinge broken, grill rusted.

The outside view shows **windows separating from the frame and letting in outdoor elements**, screening torn and not closing correctly, leading to energy loss and a security risk. Windows are currently not openable.

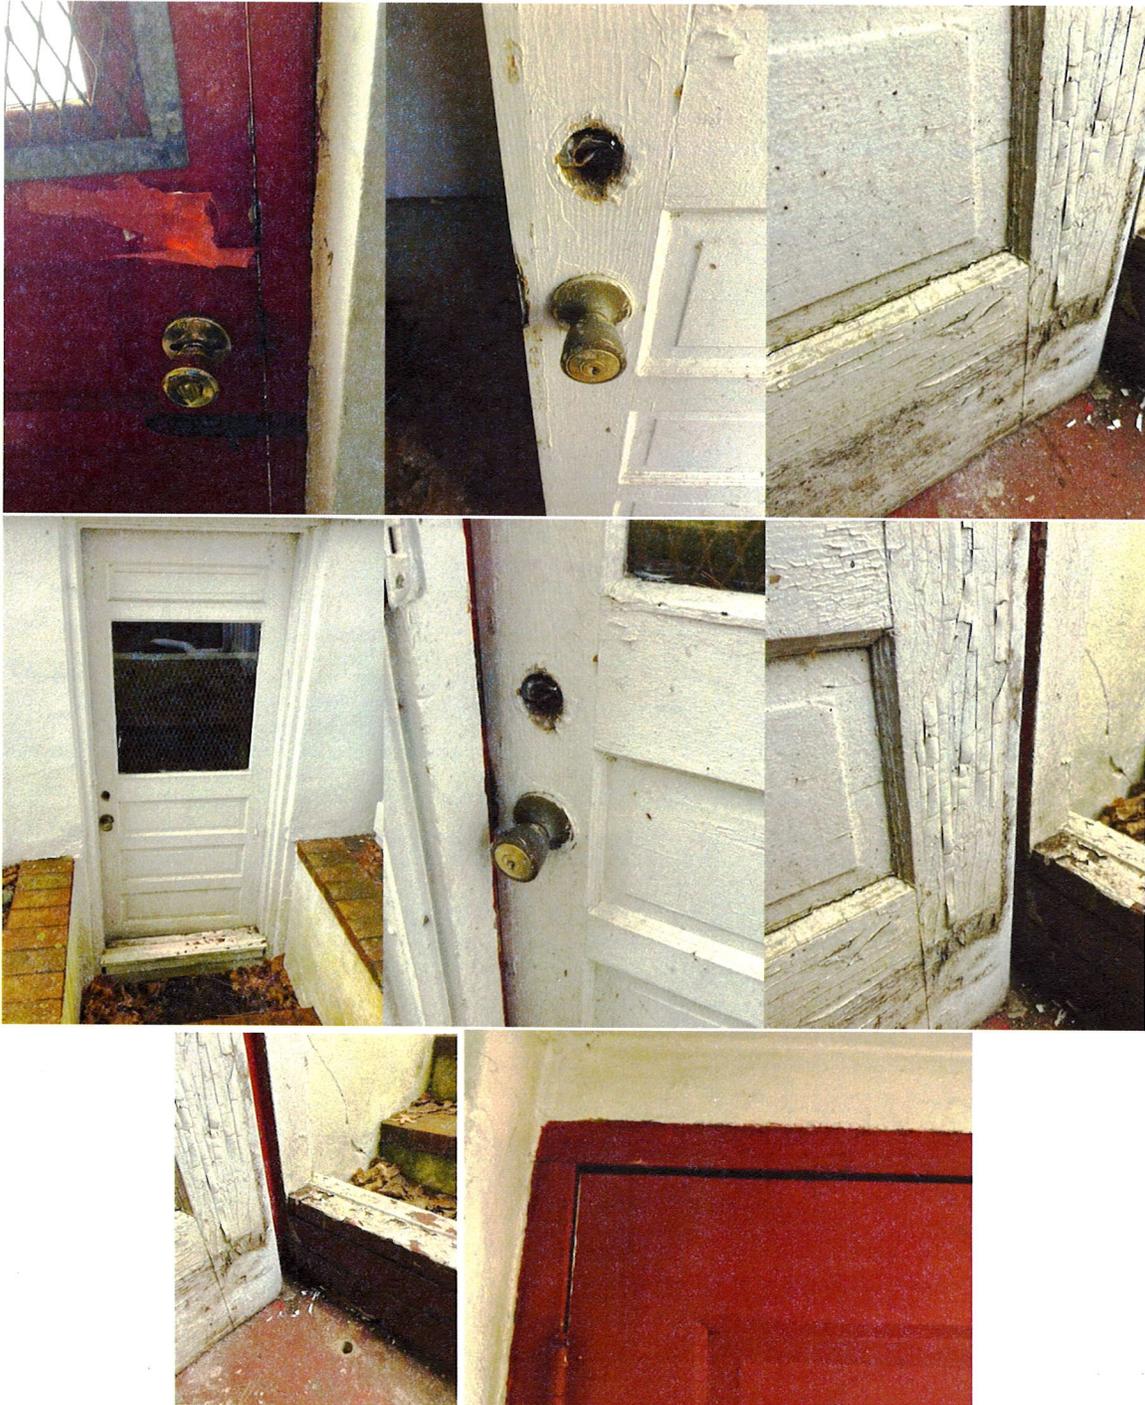
Basement door (white=outside view, red= inside view)

Outside view, the door hidden from Clifton St is white and currently rotting and needs replacing. The inside view of the door is red, which shows ill-fitting and creep from the frame, making it no longer secure. Also, there is no energy protection as an external door, making it inefficient for current standards. Presently, the door shown is in the same state when we moved in, showing red masking tape and galvanized zinc grid that does not cover the entire glass panel.
