Town Belmont
Historic District Commission
 Homer Municipal Building, 2nd Floor
 19 Moore Street
 Belmont, MA 02478

APPLICATION

Dell Residence
536 Pleasant Street
Lexington, MA

MASONRY CHIMNEY INSPECTION REPORT	
Tech: 10/04/2024	Date: John Kulik
Client: Melissa Dell	Chimney/Chase: 1 of 2
Address 536 Pleasant St Belmont MA 02478-3201	
We recommend an annual inspection of your chimney.	
Number of Flues 2	Chimney Height 5 ft
Chimney Location Interior	Courses above roof

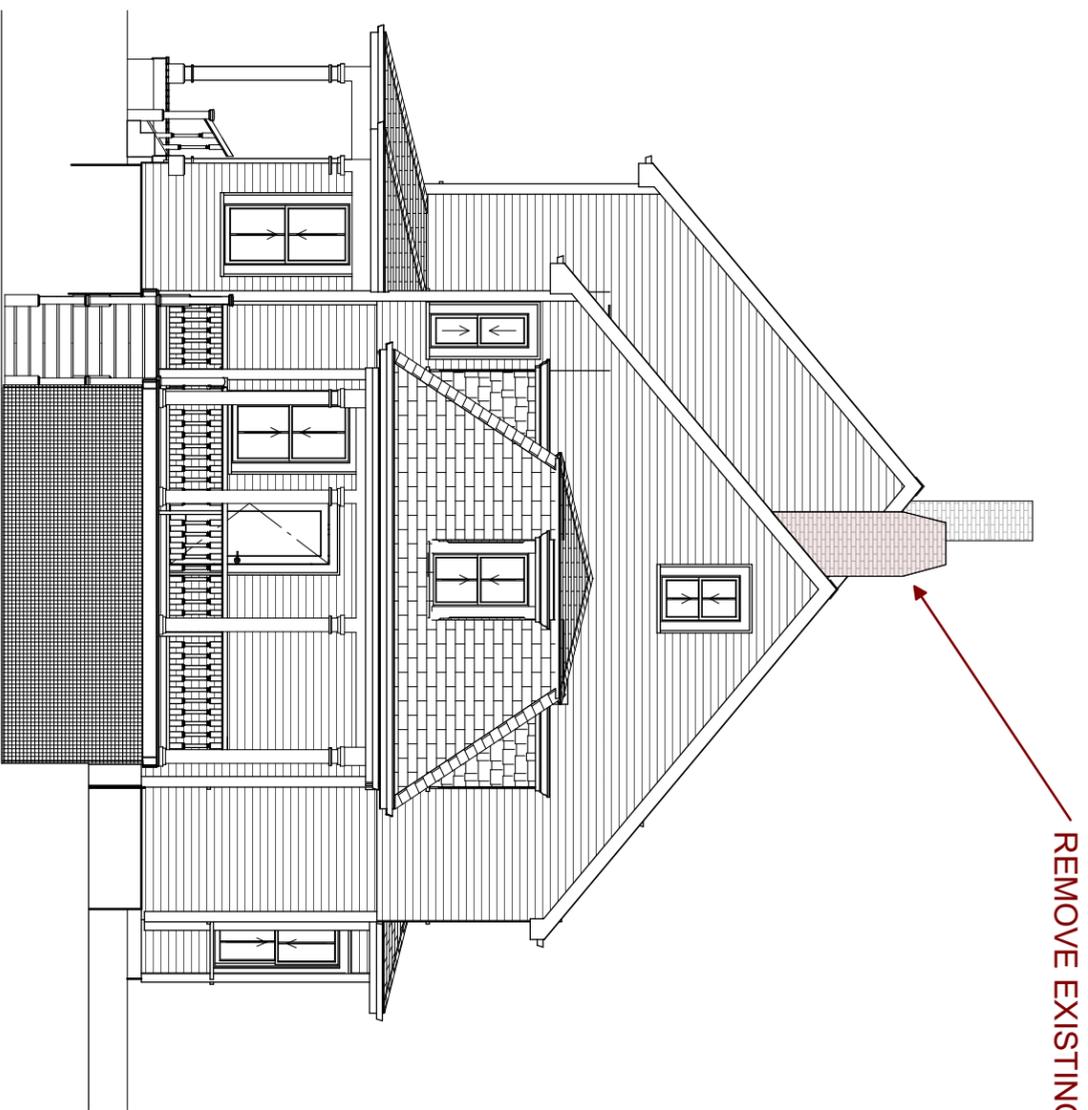
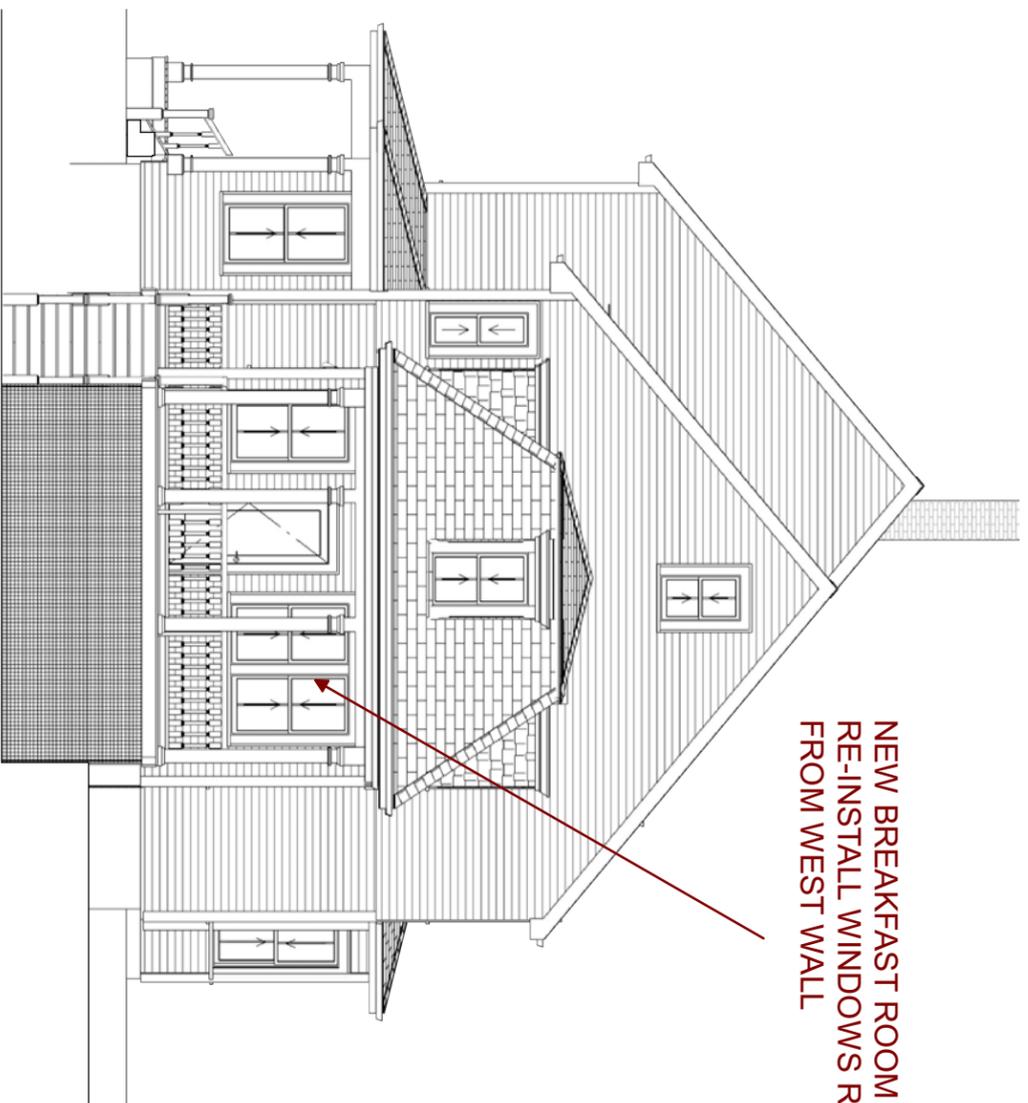
BACK ELEVATION

REMOVE EXISTING BRICK CHIMNEY

NEW BREAKFAST ROOM WINDOW
RE-INSTALL WINDOWS REMOVED
FROM WEST WALL

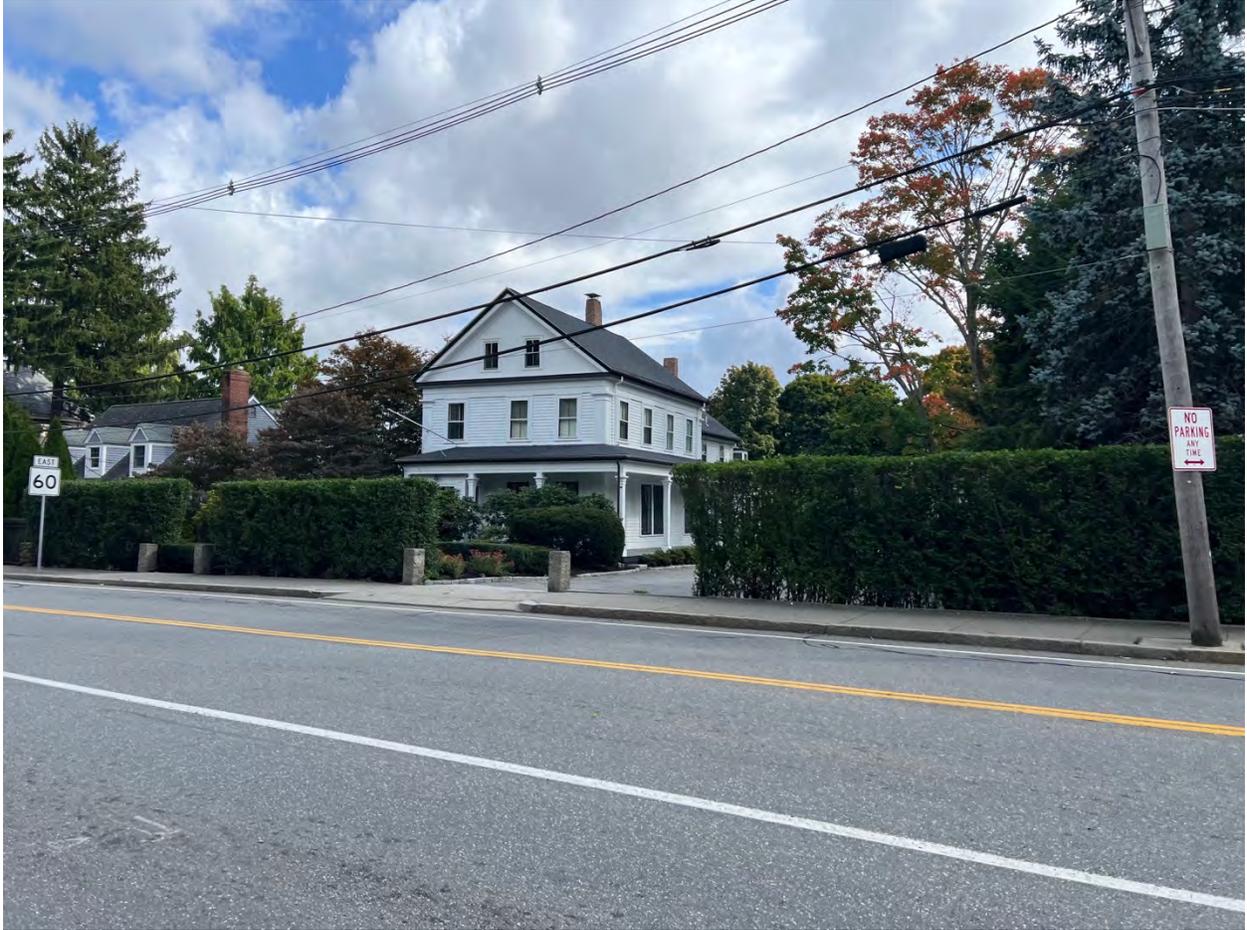
From further to the right of house, part of back chimney is visible

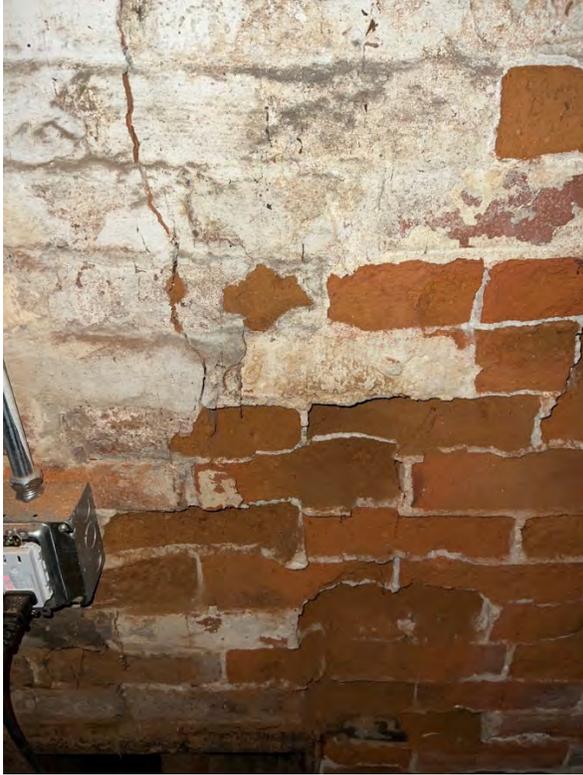
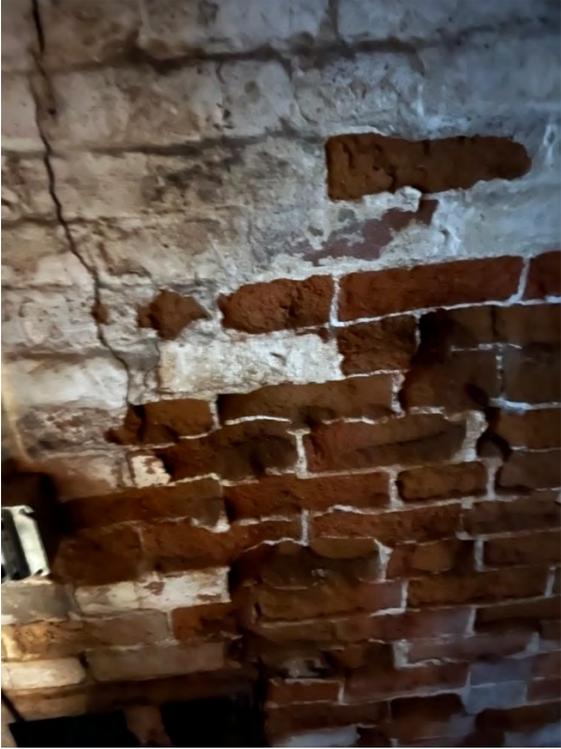
As stated in the attached letter, it would not be safe to keep just the exterior portion of the chimney (which is constructed from modern bricks). The below pictures and attached chimney inspection report show the severe deterioration at the bottom of the chimney. Given the construction of the chimney and the severe deterioration, the only way to save the chimney would be to jack the house up off the foundation, move the plumbing, and rebuild it from the base up, tearing out the kitchen and other features that block access to the firebox above. Doing foundation work would in turn require other upgrades to the foundation. This is hundreds of thousands of dollars of work and a major disruption to my family, which is completely financially and logistically infeasible for us to undertake. This leaves as the only options removing the chimney or letting it continue to deteriorate. The latter is unacceptable, as I have children in the home and if the chimney were to collapse, it would put them and our home in serious danger. Given that this is a secondary chimney, that has been reconstructed from modern bricks, and is only visible from the public way from a few vantage points, removing it would appear to be an appropriate course of action –

Here are some pictures of the deteriorating base. More pictures can be found in the attached inspection report.

The second proposed change is to remove the back chimney, whose base is in a badly deteriorated condition. There are two chimneys in the house, the primary front chimney and a secondary back chimney. Understanding the context for why we are proposing this work is important. We have been working with a company with 30 years of experience specializing in historic chimney restoration, Billy Sweet Chimney. Their recent chimney inspection report is attached. The masonry at the base of this chimney, in the cellar, is severely deteriorated. Note that this contrasts with the exterior portion of the chimney, which at some point was rebuilt with modern bricks and is not historic. Due to the deteriorated state of the chimney base and its construction, they concluded that the only way to save the chimney is to jack the house up from its foundation and rebuild the chimney from the base upwards. This will also entail moving the plumbing, since the hot water heater is installed within a eighth of an inch of the chimney base. Rebuilding the base would disrupt the walled in fireboxes above it – one of which is located between the kitchen

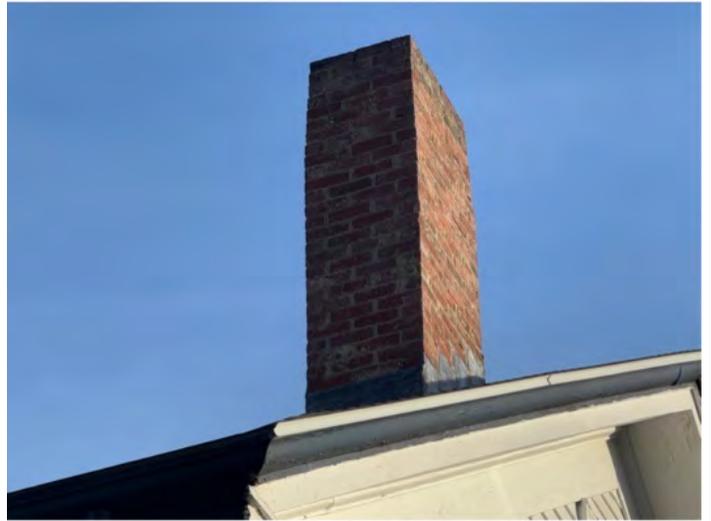
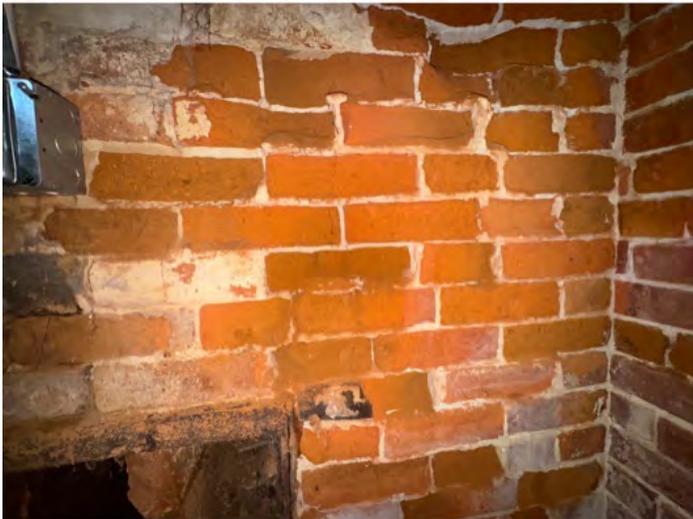
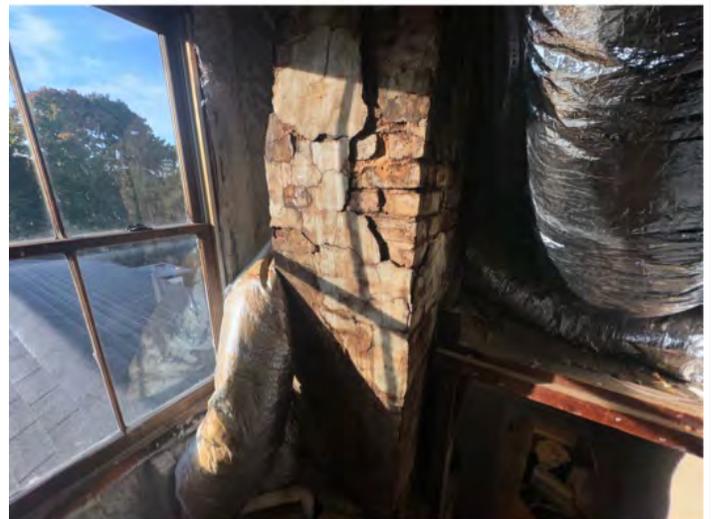
Termination Height: <i>Must be 2 ft above any structure within 10 ft and a Minimum of 3 ft above the Roof Deck</i>	
Water Penetration: Currently, there are no visible signs of water penetration	
Gutter in Relation to Chimney	
Base of Chimney Masonry Deterioration: Significant deterioration is observed in the masonry at the base of the chimney. The chimney may become unstable.

Photo shows area in question.

Annual inspections are essential for identifying any issues early and ensuring the safety and longevity of your chimney.
We recommend contacting a structural engineer to evaluate the chimney base.

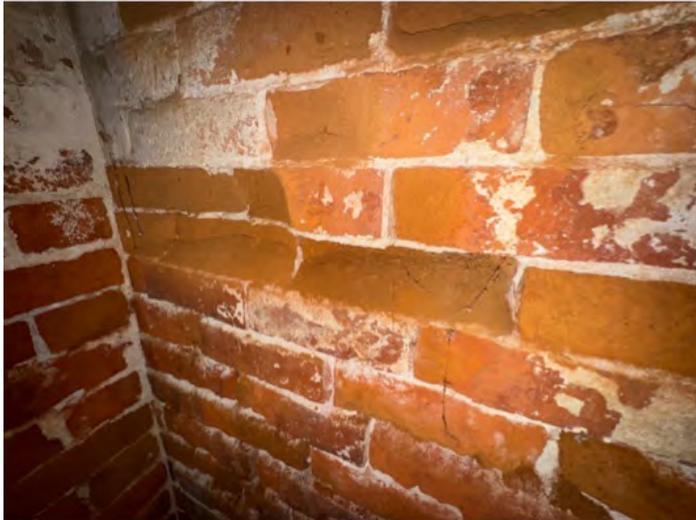
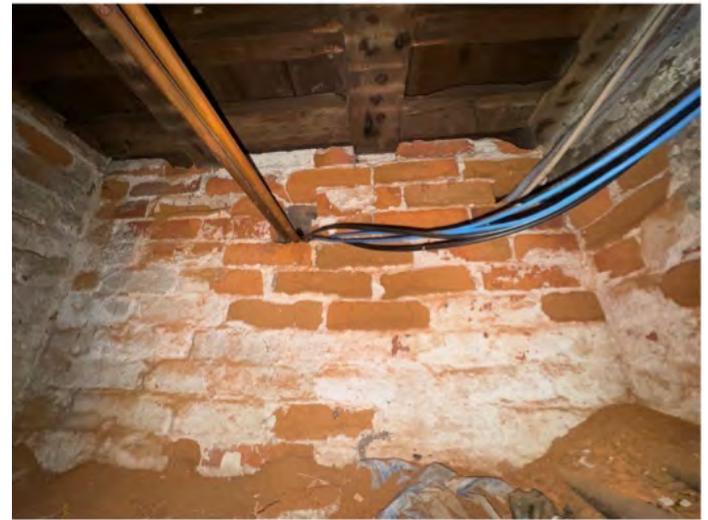
This area is a wall and not part of the chimney.
