**APPLICATION**

Address of Property: 11 Sunnyside Place, Belmont, MA 02478  
 Property Owner's Name: Chris and Julia Yates  
 Address: 11 Sunnyside Place, Belmont, MA 02478  
 Email: cmyates007@gmail.com                      Phone: 919-325-6987

**TLH CONSULTING, Inc.**  
Structural Engineering

Re: Chimney Removal / Renovations  
11 Sunnyside Place  
Belmont, MA 02478  
TLHC Project # 2202034

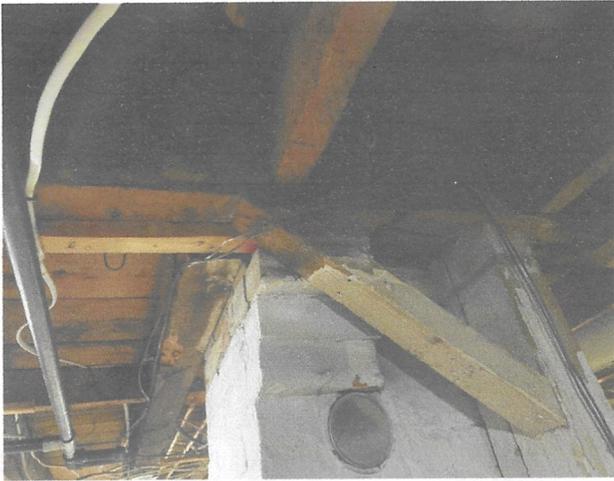
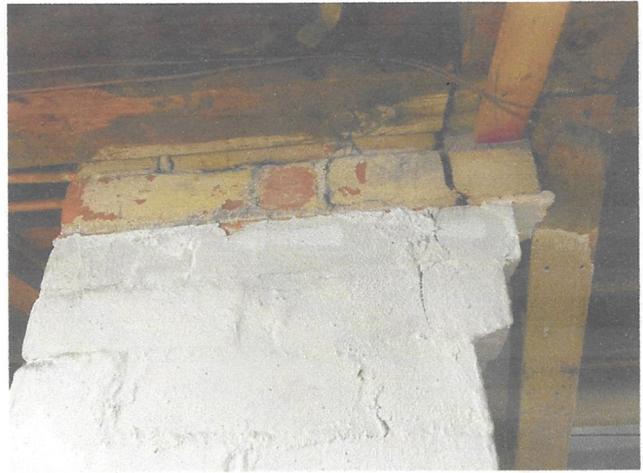
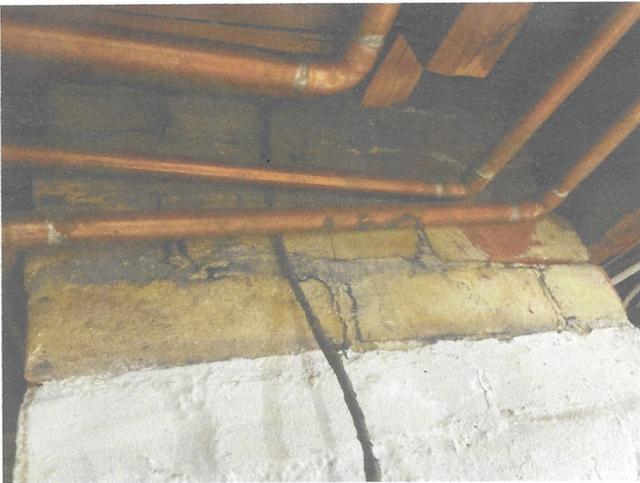
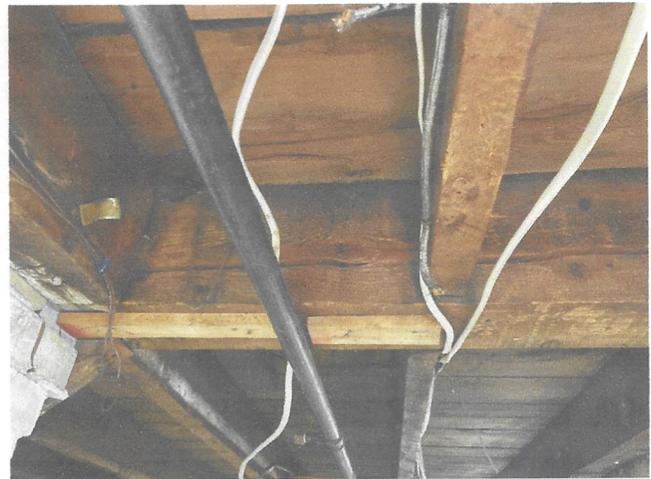
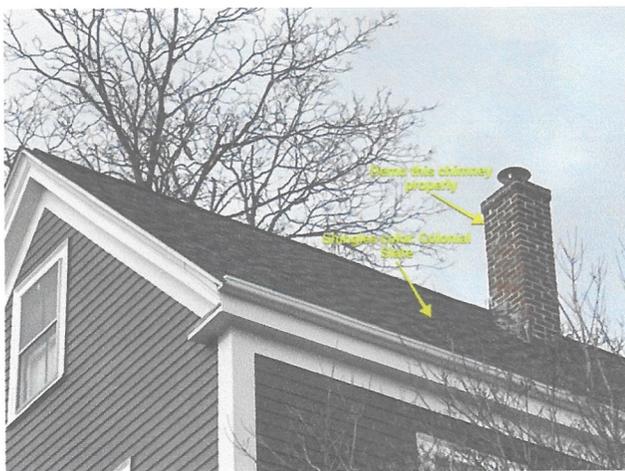
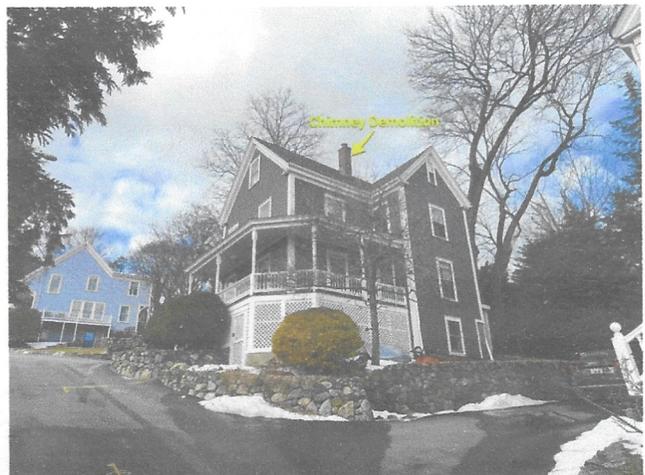
When beginning the planning for our first floor renovation and bumpout previous approved by the HDC, we discovered an issue with the main support beam for the house. After discussion with our architect, engineer, and contractor, it was decided that the best and strongest approach is to remove the chimney allowing LVL beams to be sistered to each side of that beam and installation of proper structural support. Once the chimney is removed, the roofing company that completed our roof repair a few years, ago will repair the roof so that it matches with existing roofing. Supporting documentation from the engineer and pictures are included to provide exterior views and show the discussed chimney and beam damage.

Based on our observations during the site visit, the chimney appears to be in poor condition. Many of the mortar joints are beginning to fail, several bricks with cracks, and overall signs of deterioration. In summary, we recommend removing the chimney and providing a safer temporary support prior to installing the new structural work associated with the renovation. If you have any questions, please feel free to call us at (978) 362-1804.
