OFFICE USE  
 Case Number: HDC - 25-07

Repaint the exterior of the W.F. Homer House. This application was approved by the HDC in 2024. This is a request to change the colors from matching colors currently on the building to the original historically correct colors. These are described in detail in the attached report.

# William Flagg Homer House

## Analysis of Exterior Finishes

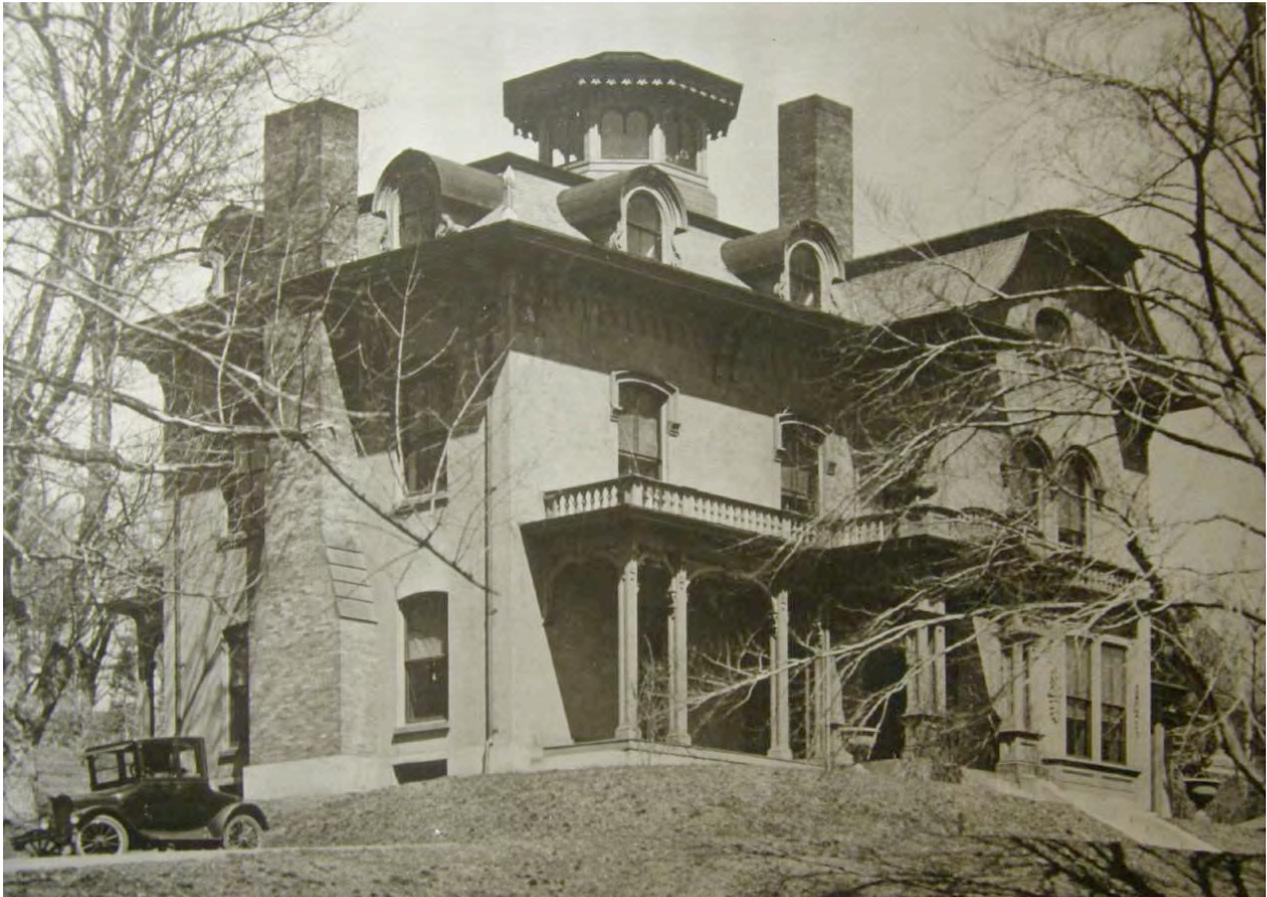
Image 1: The William Flagg Homer House, 1927, showing widow's walk railing around projecting pavilion and the absence of metal railings on the front stairs. Courtesy of Wolf Architects.

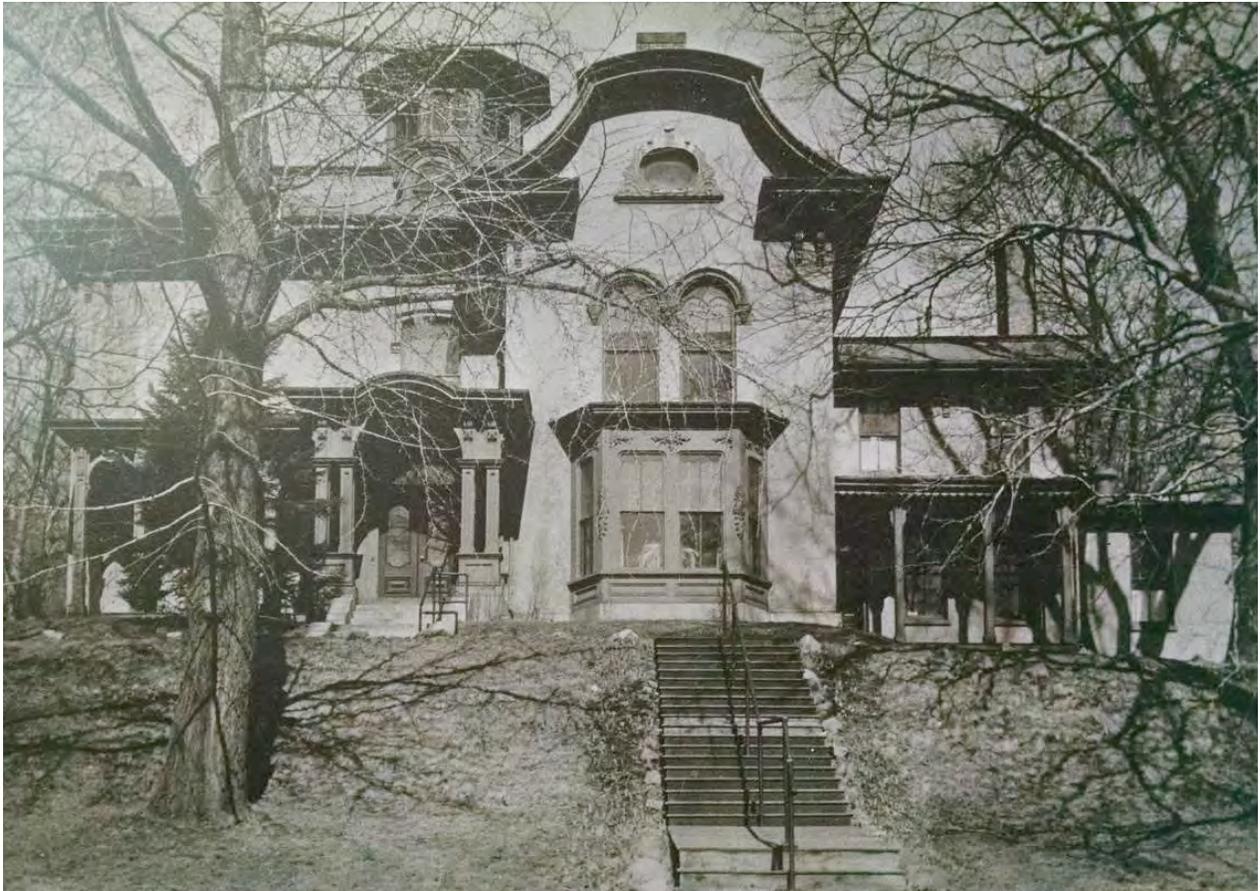
Image 2: The William Flagg Homer House, likely post-1928, showing the absence of a widow's walk railing and the addition of metal railings on the front stairs. Courtesy of Wolf Architects.

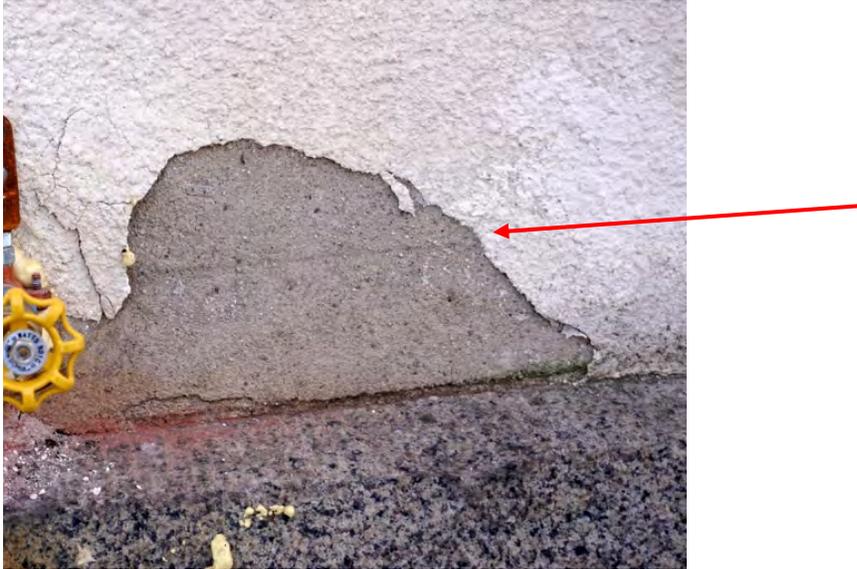
Image 3. Line struck in stucco to imitate stone.

The stucco façade was recoated sometime prior to the early twentieth century. In Image 3, it is a uniform texture. In an 1853 high-style villa, we would expect to see incised lines in the stucco to create the illusion of ashlar masonry. The original texture and struck lines (but not color) of faux ashlar masonry are shown in Image 3 below, which was taken on the north façade of the house next to the hose bib. This is a relatively hidden side of the house on the service wing that has seen less change and repairs than other exterior areas.

Image 3, above, shows the skim coat of sanded stucco without the final pigmented finish coat revealed beneath the later layers of stucco. The pigmented finish coat is stuck to the layer above, which has broken away or has worn off. This original layer of stucco was coated with a pigmented, sanded finish of tan-ochre color.<sup>3</sup> The 1853 appearance of the body of the Homer House was a warm, light honey color with the appearance of stone masonry.

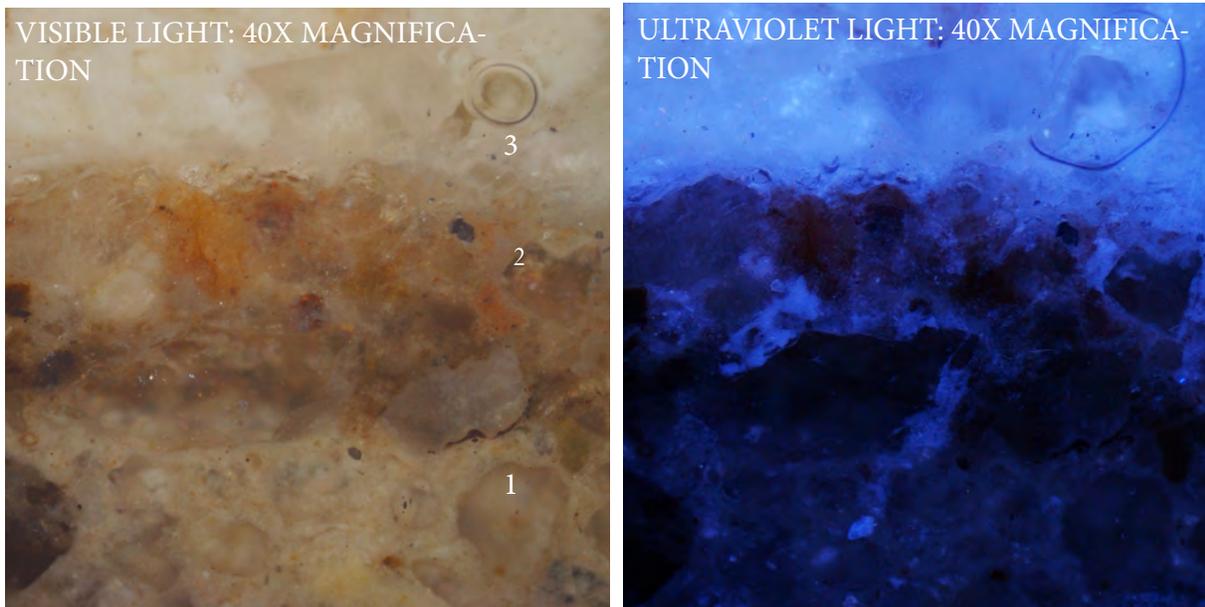
Image 4. Sample 5 shows stucco from near the roof line frieze. The original stucco color is layer 2. These two images show the sample under visible light (left) and ultraviolet radiation (right).

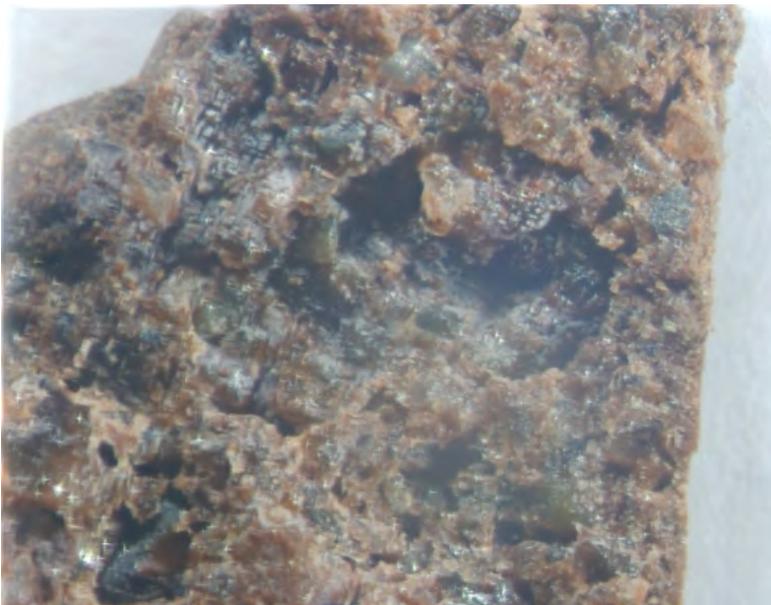
Image 5. Above, the earliest preparatory layer of sanded paint on the Homer House wood trim and ornament at approximately 6x magnification. This sanded finish layer created the texture of Brownstone. Sample 3 from the soffit on the east façade (Appendix B).

Layer 1a is an initial light brown layer of silica and quartz sand grains surround by very fine brown particles, either silt or pigment, and unevenly ground yellow and red-orange pigment particles. This layer has an orange autofluorescence, suggesting that shellac may have been included in the binder that holds the sand grains and pigment together. At low magnification, this paint layer is very grainy and spongy with large voids between the grains of sand.

Layer 1b is a coat of a similarly textured, sanded paint with a redder tinge, including more red and yellow pigment particles.

Layer 1c a thinner layer of finely-ground pigment with a browner appearance and no sand.

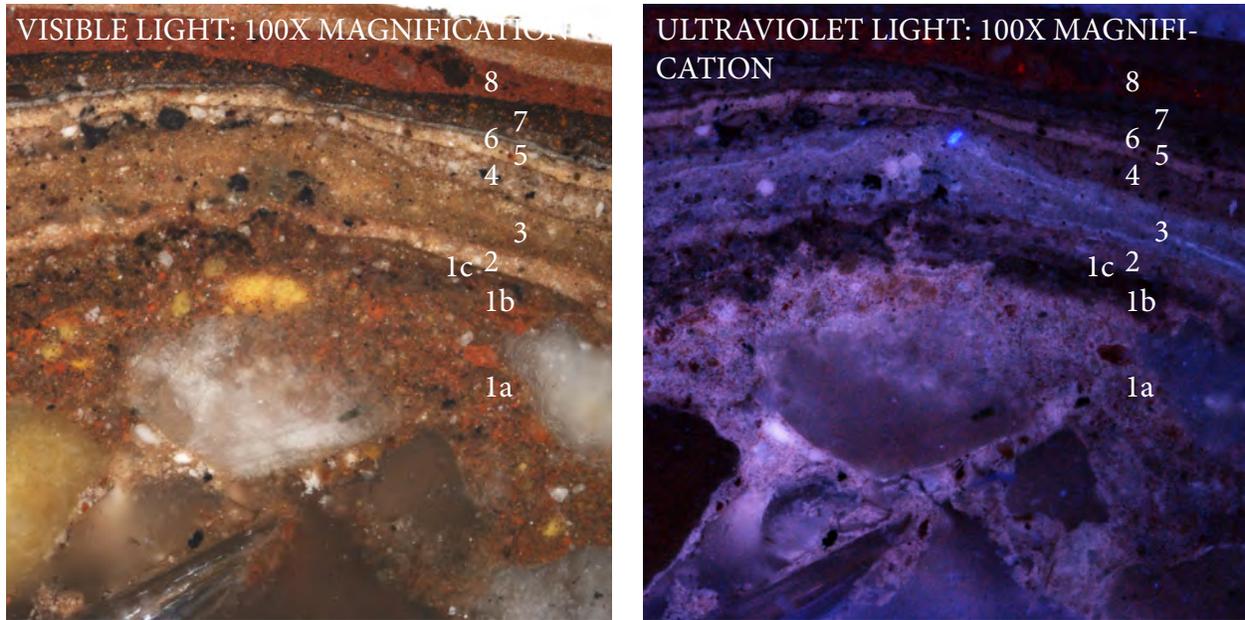
Image 6. Sample 2, from a cornice bracket, shows the early sanded finish layers that mimicked brownstone at the bottom of the image. See Appendix B for more information.

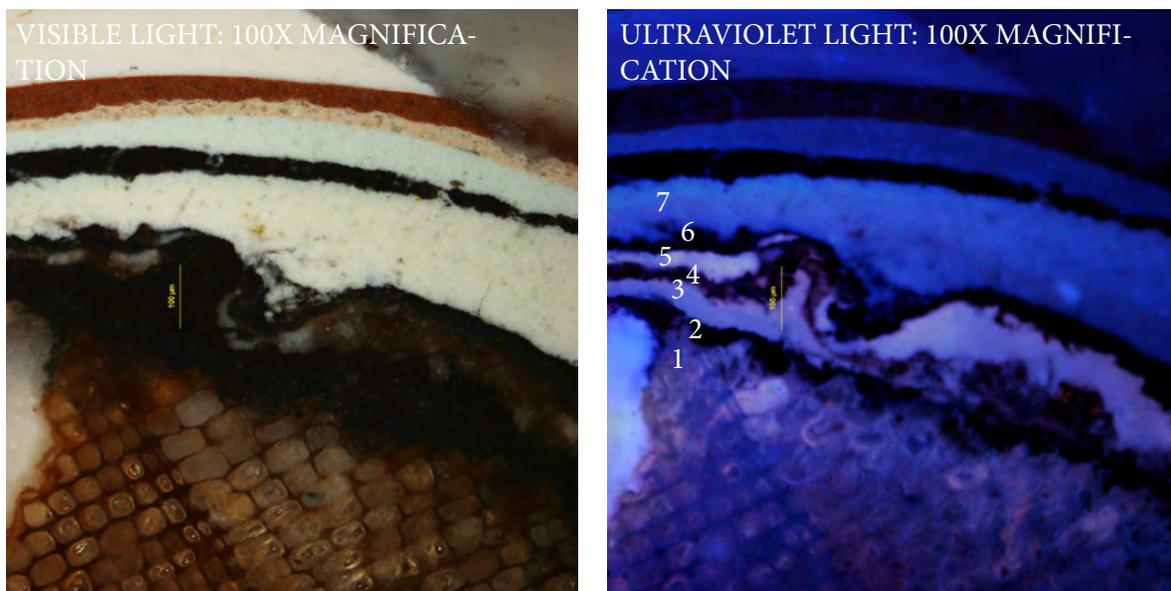
Image 7. These images show Sample 10 from the front door with wood cells on the bottom of the image. In the visible light image on the left, the earliest layers on the wood are dark or translucent. On the right, the

corresponding area of the image has alternating black and white wavy layers. This is characteristic of a graining, or faux bois, decorative finish.

The sampling from these two doors shows early layers of varnishes and waxes. These layers are translucent in white light but have distinctive characteristics when viewed under ultraviolet radiation (Image 7).

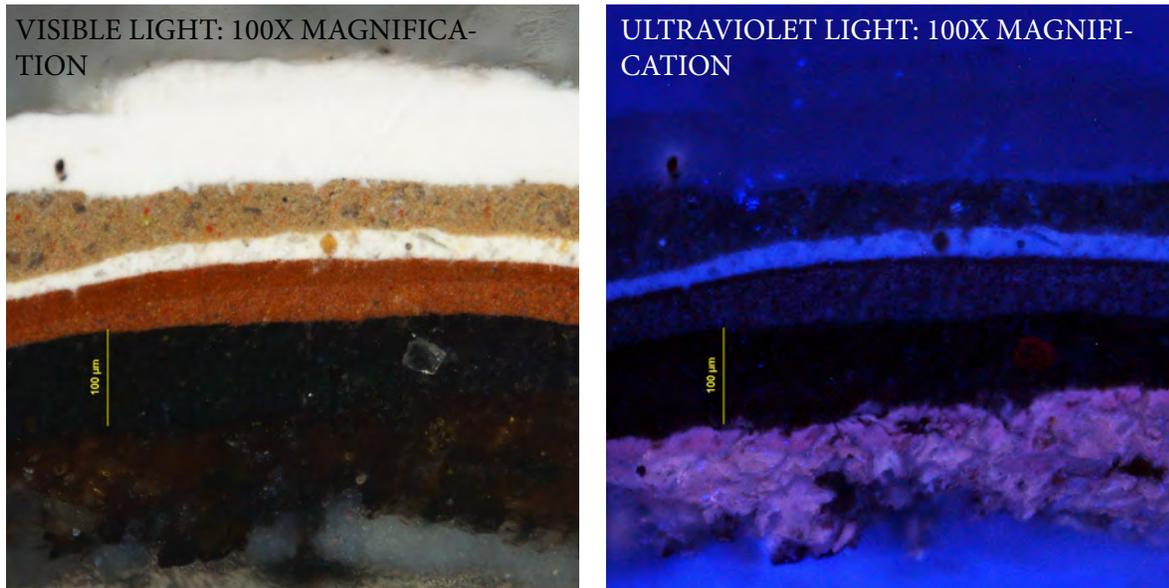
Image 8. Sample 11, from the service entry door, has early layers of a translucent finish but they do not have the same bright white layers of auto fluorescence displayed by sample 10, above.

The service entry door of the Homer House was originally finished with a clear coat or graining pattern. Sample 11 shows translucent early layers but not the same obvious graining series that the front door sample reveals (Image 8).

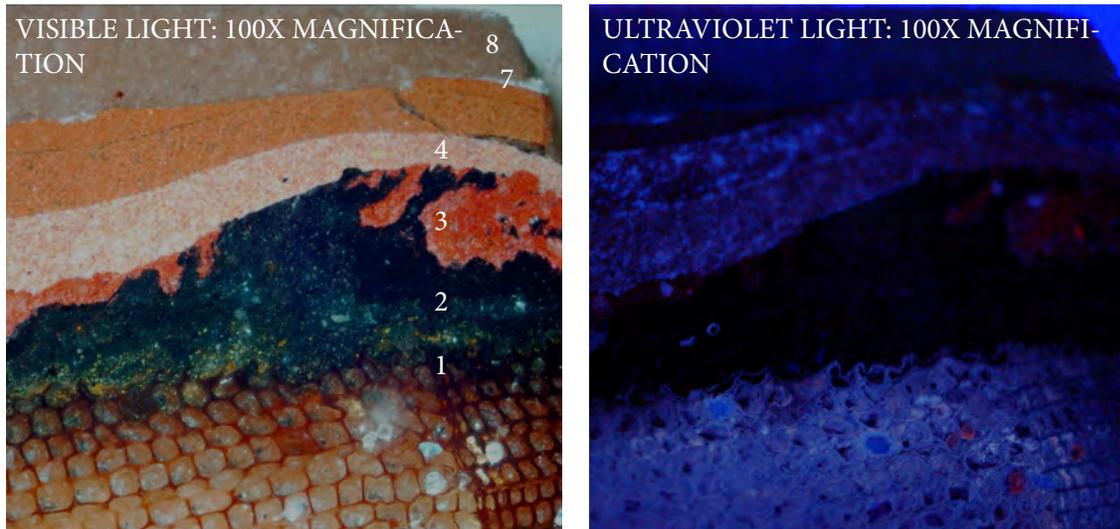
Image 9. Sample 15 shows the black of the window sash. Understanding the small amount of red present in Sample 15 requires further sampling or manual exposure.

The earliest layer of window sash is a black hue. This color was found on the sash of a window on north façade that is covered on the inside by an icebox (Sample 12). It is also present on the east façade French door/window immediately south of the front door, and this sample is shown below (Sample 15). A clear coat such as shellac was applied to the sash and then a black paint was applied (Image 9).

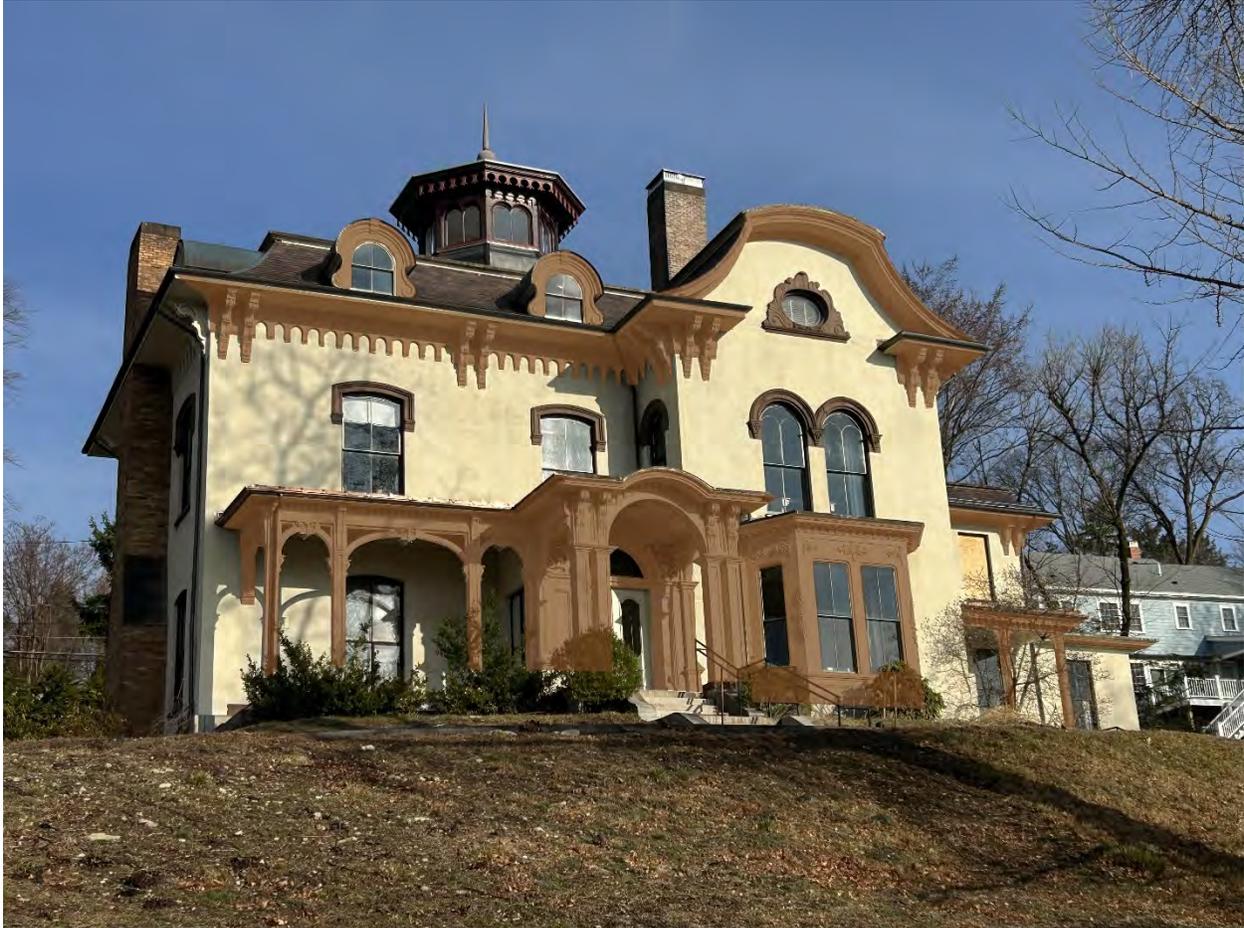
The following rendering shows the elements on the Homer House that likely were originally painted with a dark brown sanded paint. BCA recommends that all elevations of the building be painted in a similar fashion. Note that the second windows and third floor oculus window have brownstone hoodmolds and sills, but the dormer window hoodmolds would have been painted brown to match.

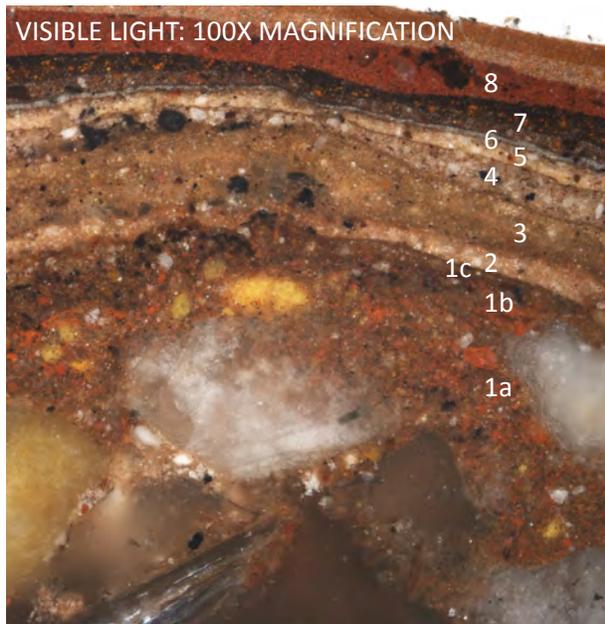
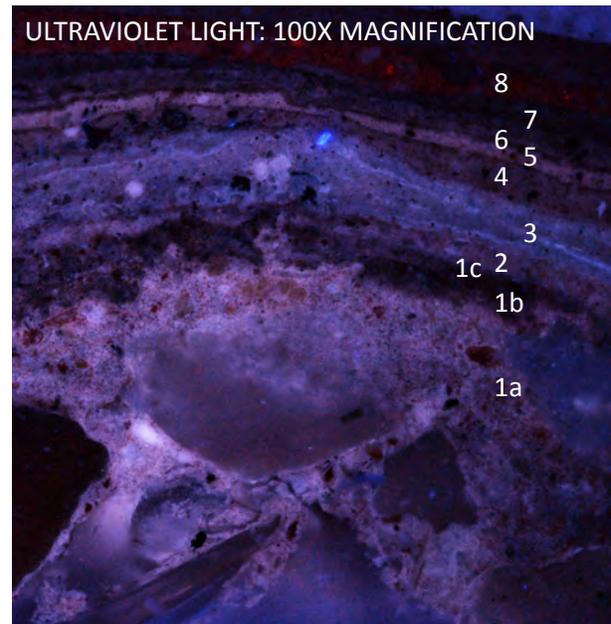
<b>SAMPLE: 2</b>	<b>LOCATION:</b> Bracket, east entrance portico, side
<b>DATE SAMPLED:</b> 27 January 2025	<b>DATE ANALYZED:</b> March 2025
<b>SAMPLED BY:</b> L. Lacombe	<b>ANALYZED BY:</b> R. Krieger & L. Lacombe
<b>MICROSCOPE:</b> Nikon Eclipse 80i compound fluorescence microscope	<b>CAMERA:</b> Nikon DS-Fi1
<b>DESCRIPTION:</b> First layer is characterized by a wide, sanded finish that was brittle and fractured from substrate when samples were collected. This layer has a fine brown matrix with uneven, hand-ground red and yellow pigment particles and larger white, beige, and transparent sand particles for texture.

LAYER	REFLECTED LIGHT COLOR	NOTES
[finish layers continue]		
8	reddish brown	
7	dark brown	red pigment
6	gray	very thin
5	beige	soil layer
4	light brown	soil layer
3	brown	soil layer
2	light brown	
1c	brown	
1b	reddish brown	sanded
1a	light brown	sanded
Substrate: wood (missing)

LAYER	UV LIGHT COLOR	NOTES
[finish layers continue]		
8	dark	
7	dark	
6	dark	
5	orange	
4	dark with blue	
3	light blue	thin blue layers
2	orange	
1c	dark	
1b	dark	
1	orange	pigment is dark red
Substrate: wood (missing)

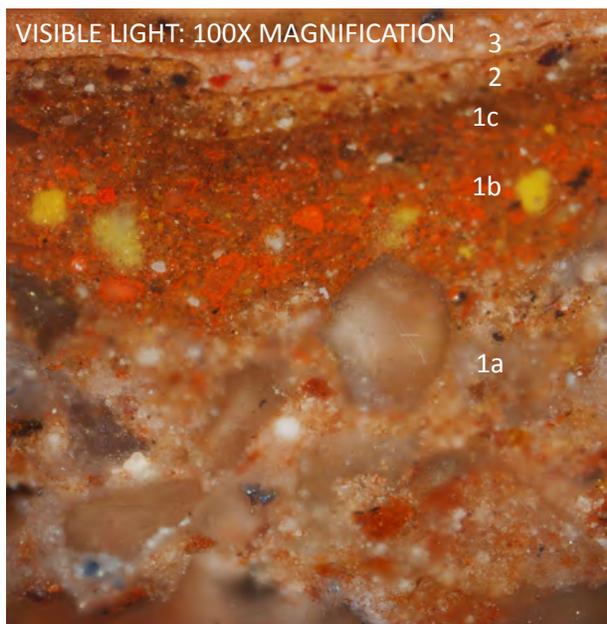
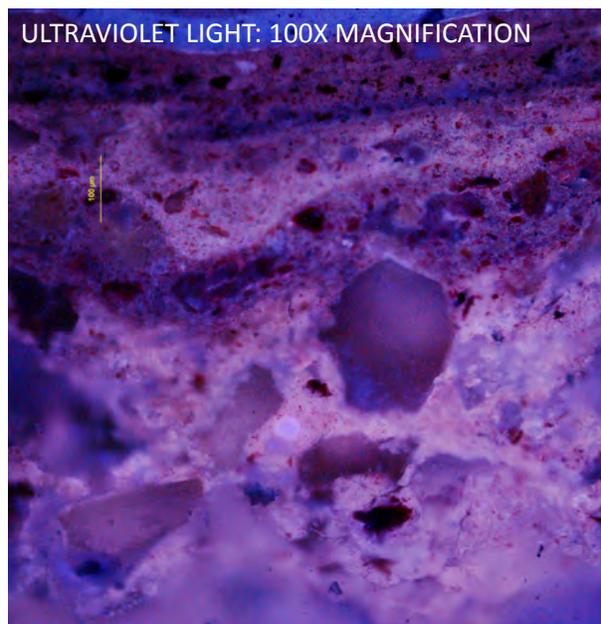
<b>SAMPLE: 3</b>	<b>LOCATION:</b> Soffit, east entrance portico
<b>DATE SAMPLED:</b> 27 January 2025	<b>DATE ANALYZED:</b> March 2025
<b>SAMPLED BY:</b> L. Lacombe	<b>ANALYZED BY:</b> R. Krieger & L. Lacombe
<b>MICROSCOPE:</b> Nikon Eclipse 80i compound fluorescence microscope	<b>CAMERA:</b> Nikon DS-Fi1
<b>DESCRIPTION:</b> The initial finish layer has large sanded particles in a matrix of medium brown fine sand and red and yellow pigment particles. In this sample, an initial layer of medium sanded brown is followed by a layer of more intense reddish brown, the presentation layer of the first paint campaign.

LAYER	REFLECTED LIGHT COLOR	NOTES
[finish layers continue]		
3	light brown	
2	medium brown	soil layer
1c	chocolate brown	soil layer
1b	reddish brown	sanded
1a	light brown	sanded
Substrate: wood (disrupted)

LAYER	UV LIGHT COLOR	NOTES
[finish layers continue]		
3	brown	
2	brown	
1c	orange	
1b	brown	dark red particles
1a	orange	dark red particles
Substrate: wood (disrupted)

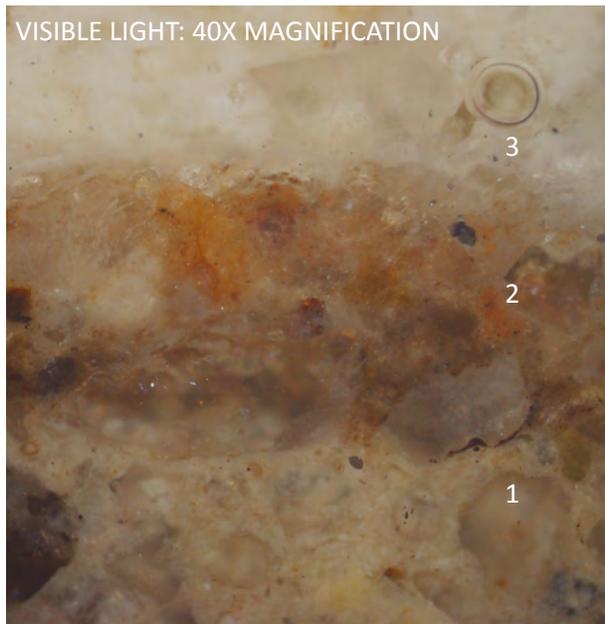
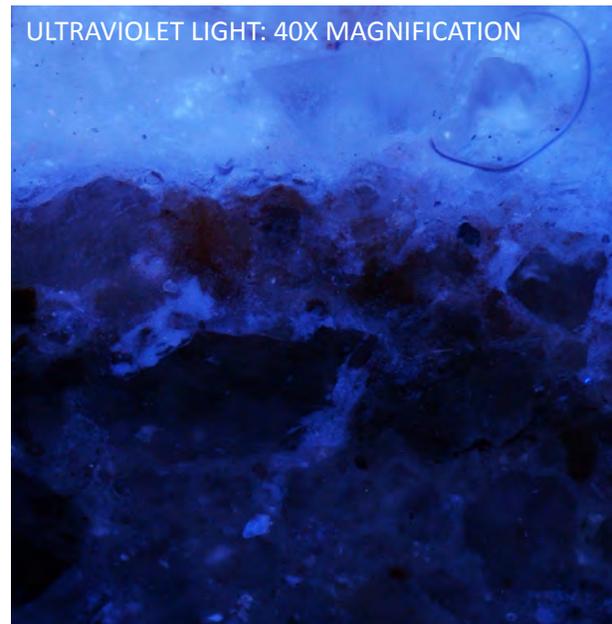
<b>SAMPLE: 4</b>	<b>LOCATION:</b> Stucco at edge of roof line frieze relief (element was already spalling)
<b>DATE SAMPLED:</b> 27 January 2025	<b>DATE ANALYZED:</b> March 2025
<b>SAMPLED BY:</b> L. Lacombe	<b>ANALYZED BY:</b> R. Krieger & L. Lacombe
<b>MICROSCOPE:</b> Nikon Eclipse 80i compound fluorescence microscope	<b>CAMERA:</b> Nikon DS-Fi1
<b>DESCRIPTION:</b> This sample shows a thin layer of pigmented finish coat over the original stucco layer under a very thick application of twentieth-century stucco.

LAYER	REFLECTED LIGHT COLOR	NOTES
[finish layers continue]		
3	white	thick stucco layer
2	peachy beige	thin pigmented finish
1	off-white	stucco finish
Substrate: stucco

LAYER	UV LIGHT COLOR	NOTES
[finish layers continue]		
3	blue white	thick stucco
2	blue matrix with dark aggregate	sanded, lime-based finish
1	dark	stucco finish
Substrate: stucco

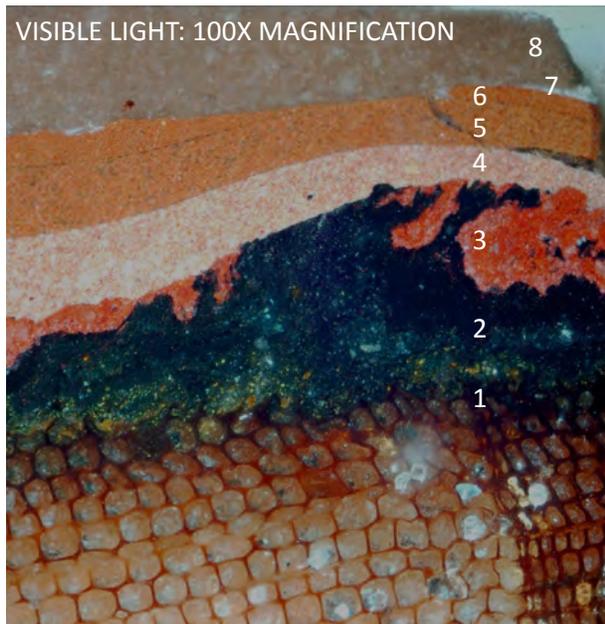
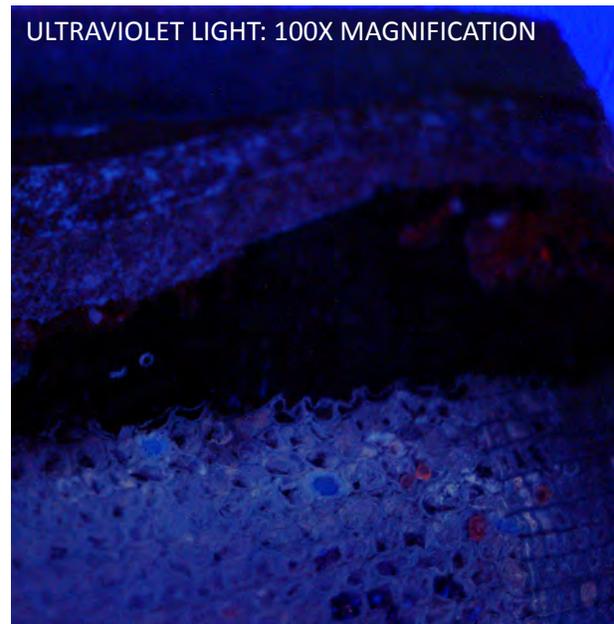
<b>SAMPLE: 5</b>	<b>LOCATION:</b> window sash, south of front door, east elevation
<b>DATE SAMPLED:</b> 27 January 2025	<b>DATE ANALYZED:</b> March 2025
<b>SAMPLED BY:</b> L. Lacombe	<b>ANALYZED BY:</b> R. Krieger & L. Lacombe
<b>MICROSCOPE:</b> Nikon Eclipse 80i compound fluorescence microscope	<b>CAMERA:</b> Nikon DS-Fi1
<b>DESCRIPTION:</b> The sample of the window sash of the front door has more layers than Sample 11, the servant's entry door, but has a similar layer structure overall.

LAYER	REFLECTED LIGHT	NOTES
[finish layers continue]		
8	brown	
7	white	removed
6	light red	
5	light red	
4	peach	
3	red	removed or decorative
2	dark gray	yellow pigment
1	translucent w/ pigment	clear coat
Substrate: wood

LAYER	UV LIGHT COLOR	NOTES
[finish layers continue]		
8	dark blue	
7	bright blue	
6	dark	
5	blue with dark particles	
4	blue with dark particles	
3	dark	
2	dark	
1	orange w/ red and blue pigment particles	shellac
Substrate: wood

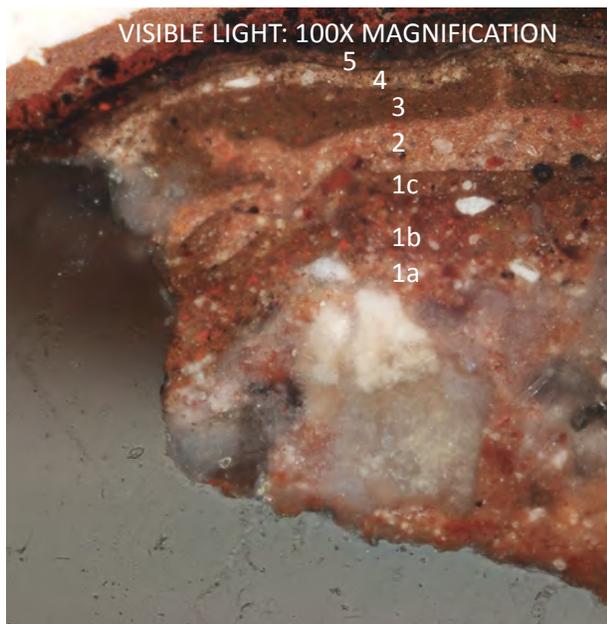
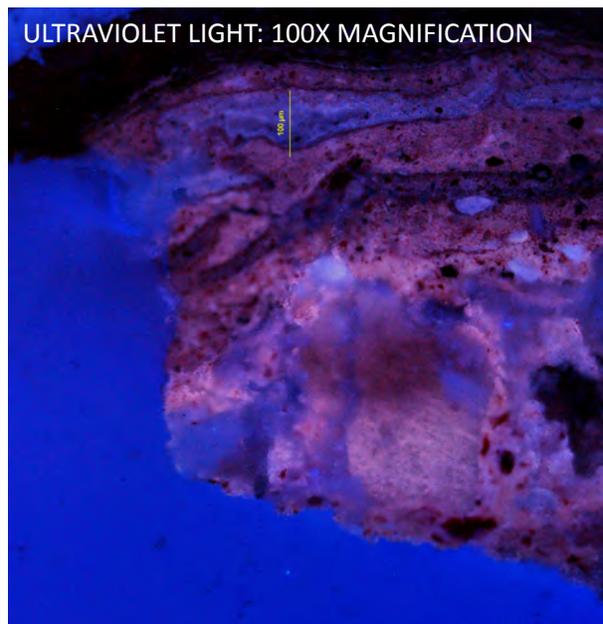
<b>SAMPLE: 6</b>	<b>LOCATION:</b> Bracket, northeast corner of north facade.
<b>DATE SAMPLED:</b> 27 January 2025	<b>DATE ANALYZED:</b> March 2025
<b>SAMPLED BY:</b> R. Krieger	<b>ANALYZED BY:</b> R. Krieger & L. Lacombe
<b>MICROSCOPE:</b> Nikon Eclipse 80i compound fluorescence microscope	<b>CAMERA:</b> Nikon DS-Fi1
<b>DESCRIPTION:</b> This sample shows the many generations of colors on the building's wood ornament, window and door surrounds. The earliest layers have large sand aggregate with red and yellow pigment particles in a fine brown matrix.

LAYER	REFLECTED LIGHT COLOR	NOTES
[finish layers continue]		
5	medium brown	
4	light brown	soil layer
3	medium brown	soil layer
2	light brown	
1c	brown	soil layer
1b	reddish brown	sanded
1a	brown	sanded
Substrate: wood

LAYER	UV LIGHT COLOR	NOTES
[finish layers continue]		
5	dark	
4	beige brown	
3	blue	soil layer
2	dark orange	soil layer
1c	brown	
1b	dark red particles	
1a	orange	
Substrate: wood

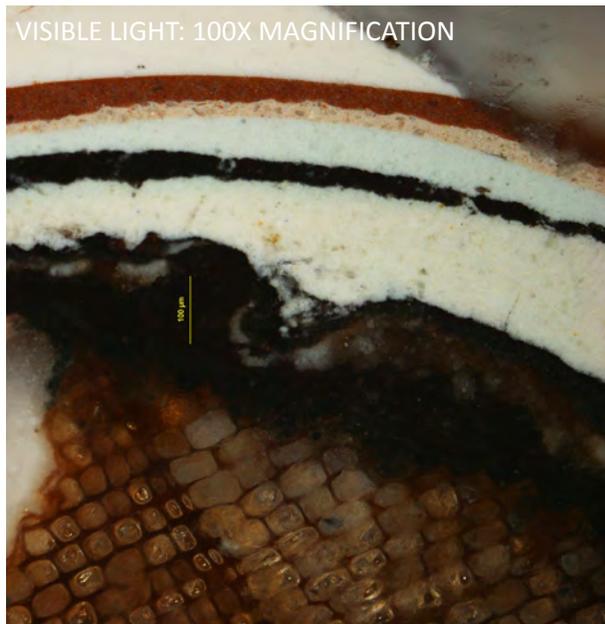
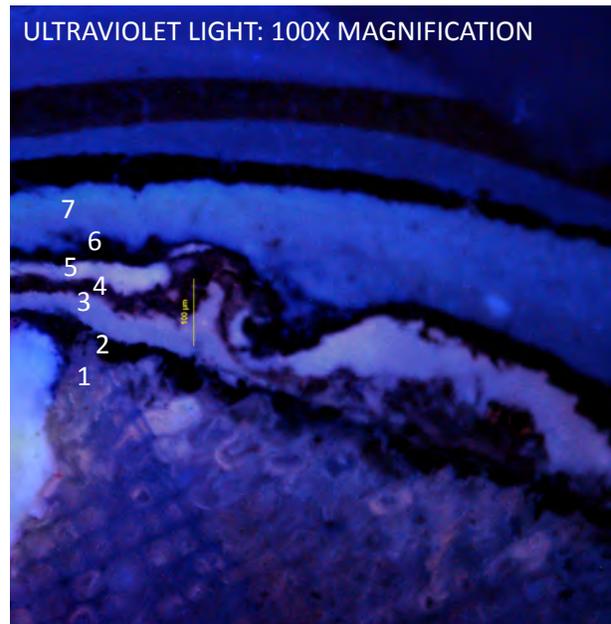
<b>SAMPLE: 10</b>	<b>LOCATION:</b> front door, north leaf, east facade
<b>DATE SAMPLED:</b> 27 January 2025	<b>DATE ANALYZED:</b> March 2025
<b>SAMPLED BY:</b> R. Krieger	<b>ANALYZED BY:</b> R. Krieger & L. Lacombe
<b>MICROSCOPE:</b> Nikon Eclipse 80i compound fluorescence microscope	<b>CAMERA:</b> Nikon DS-Fi1
<b>DESCRIPTION:</b> The finish sample on this wood door shows a patter of early translucent finishes of resin varnish and wax.

LAYER	REFLECTED LIGHT COLOR	NOTES
[layers continue]		
7	off white	
6	black	possible clear coat
5	white and brown	clear coat/graining
4	translucent	clear coat
3	translucent	clear coat
2	translucent	clear coat
1	translucent	clear coat
Substrate: wood

LAYER	UV LIGHT COLOR	NOTES
[layers continue]		
7	blue	paint
6	black	wax
5	white	pigmented varnish
4	black	wax
3	white	varnish
2	black	wax
1	orange	shellac
Substrate: wood

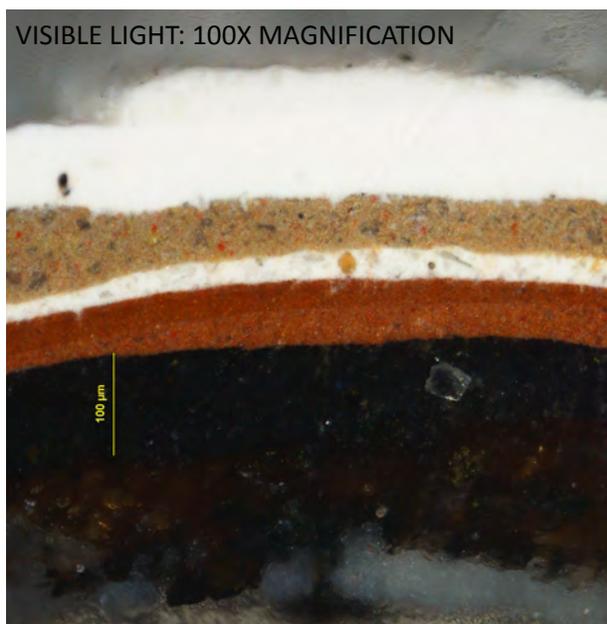
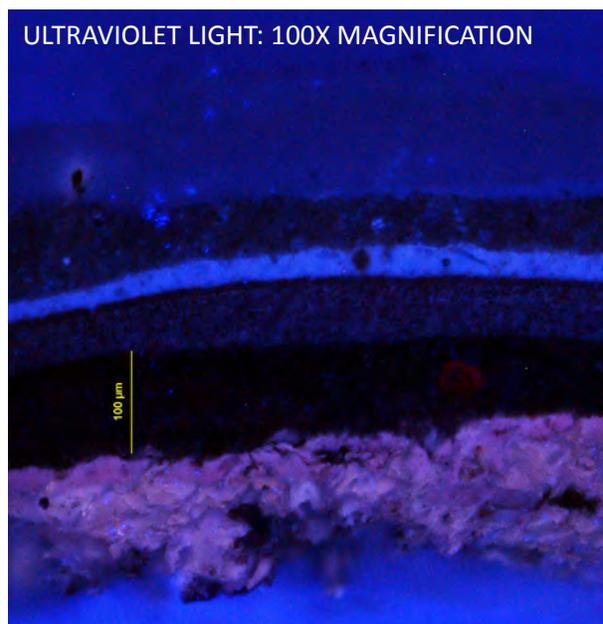
<b>SAMPLE: 11 Door</b>	<b>LOCATION:</b> East facade, door to servants entry/kitchen
<b>DATE SAMPLED:</b> 27 January 2025	<b>DATE ANALYZED:</b> March 2025
<b>SAMPLED BY:</b> R. Krieger	<b>ANALYZED BY:</b> R. Krieger & L. Lacombe
<b>MICROSCOPE:</b> Nikon Eclipse 80i compound fluorescence microscope	<b>CAMERA:</b> Nikon DS-Fi1
<b>DESCRIPTION:</b> The sample, from the servants' entry door, has a similar layer structure to Sample 5, a French door/window on the front facade of the house.

LAYER	REFLECTED LIGHT COLOR	NOTES
7	white	
6	medium brown	
5	white	
4	light red	
3	orange	
2	dark gray	
1	translucent w/ pigment	clear coat (shellac)
Substrate: wood

LAYER	UV LIGHT COLOR	NOTES
7	dark blue	
6	dark	
5	bright blue	
4	blue with particles	
3	blue with particles	
2	dark	
1	orange	shellac
Substrate: wood

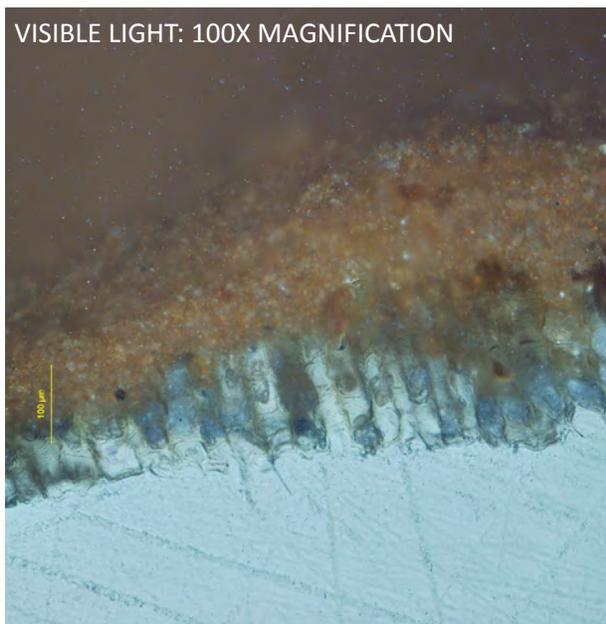
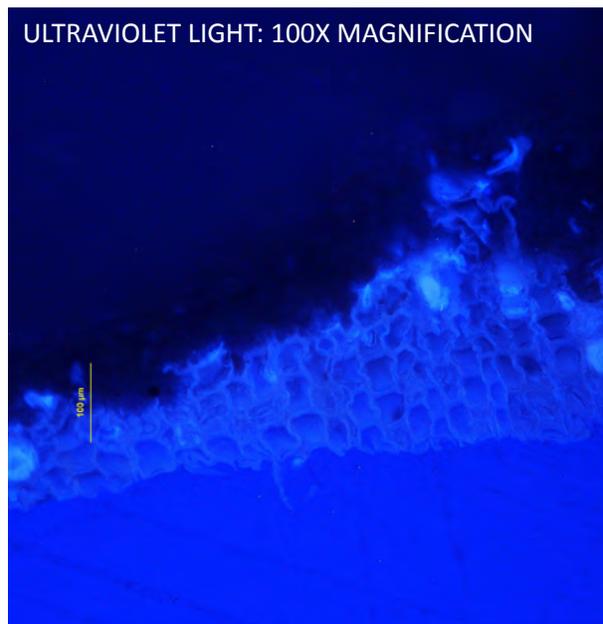
<b>SAMPLE: 13 Window Frame</b>	<b>LOCATION:</b> window frame, lower left of west window behind icebox, north facade
<b>DATE SAMPLED:</b> 27 January 2025	<b>DATE ANALYZED:</b> March 2025
<b>SAMPLED BY:</b> R. Krieger	<b>ANALYZED BY:</b> R. Krieger & L. Lacombe
<b>MICROSCOPE:</b> Nikon Eclipse 80i compound fluorescence microscope	<b>CAMERA:</b> Nikon DS-Fi1
<b>DESCRIPTION:</b> This sample has fewer layers of paint. The window is in a low-visibility area of the servants wing. May match Layer 2 of other window samples given lack of autofluorescence.

LAYER	REFLECTED LIGHT COLOR	NOTES
3	brown	
2	brown	
1	transparent	clear coat (varnish)
Substrate: wood

LAYER	UV LIGHT COLOR	NOTES
3	dark	
2	dark	
1	bright blue	varnish
Substrate: wood

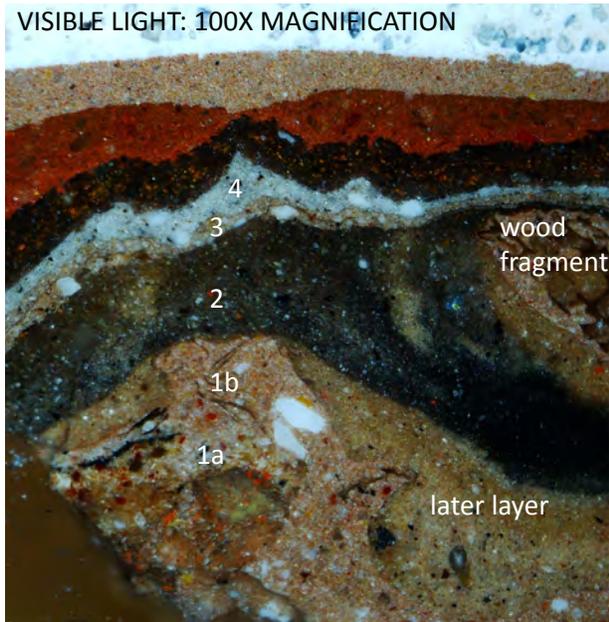
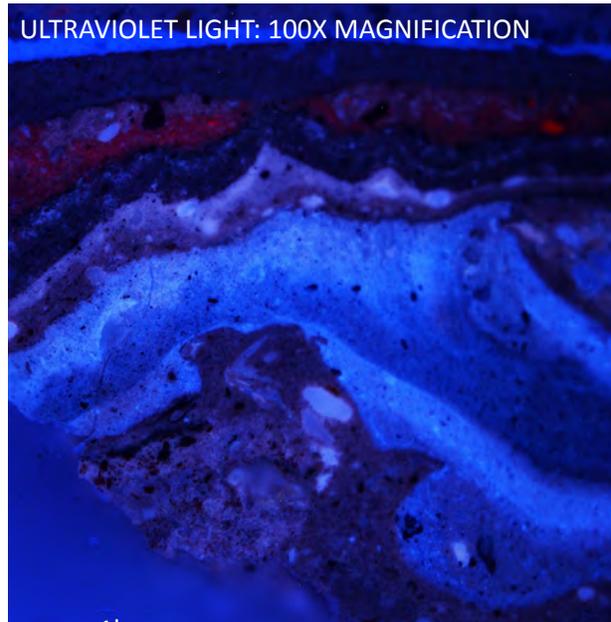
<b>SAMPLE: 15</b>	<b>LOCATION:</b> dormer window surround inner reveal, center dormer, west facade
<b>DATE SAMPLED:</b> 27 January 2025	<b>DATE ANALYZED:</b> March 2025
<b>SAMPLED BY:</b> R. Krieger	<b>ANALYZED BY:</b> R. Krieger & L. Lacombe
<b>MICROSCOPE:</b> Nikon Eclipse 80i compound fluorescence microscope	<b>CAMERA:</b> Nikon DS-Fi1
<b>DESCRIPTION:</b> The sample shows early layers of sanded browns with yellow and red pigment, similar to brackets and soffit (but not the other windows). The later layers have more in common with east facade door colors. The sample's wood substrate is deteriorated and fragmented, allowing later layers to flow under others, and with floating fragments of wood.

VISIBLE LIGHT: 100X MAGNIFICATION

ULTRAVIOLET LIGHT: 100X MAGNIFICATION

LAYER	REFLECTED LIGHT COLOR	NOTES
[finish layers continue]		
4	pale gray	
3	medium brown	
2	dark gray	
1b	medium brown	red pigment, sanded
1a	medium brown	red pigment, sanded
Substrate: wood

LAYER	UV LIGHT COLOR	NOTES
[finish layers continue]		
4	cream	
3	brown	
2	blue-white	
1b	brown	
1a	light brown	
Substrate: wood
