FORM B – BUILDING

Town/City: Belmont

Address: 18 Oak Avenue

Historic Name: John L. Goss House

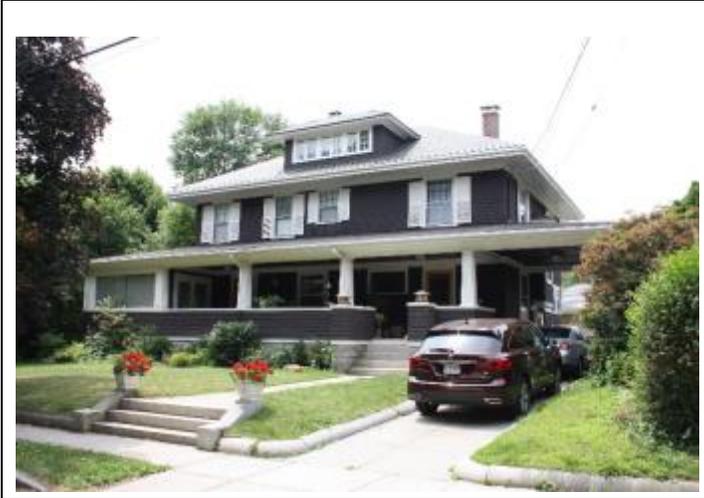
Photograph

Constructed in 1915, the Goss House at 18 Oak Avenue is a Craftsman style, wood-shingled dwelling that shows the influence of the Prairie Style in its widely overhanging eaves and its sense of horizontality which is reinforced by the placement of a porch on one side of the main house block and a porte cochere on the other. The front porch and porte cochere display squat, tapered porch posts that rest on a shingled wall. The somewhat unusual use of granite blocks under the porch and porte cochere is a reflection of the original owner who was a granite manufacturer. The windows include double-hung windows with 6/1 and 8/1 sash as well as a stained glass window and rectangular oriel window on the north wall. The front hip dormer was originally smaller but was enlarged in 2008. This and the enclosure of the south porch are the only minimal alterations that the house has seen since its construction.

Behind the house is a stuccoed garage capped by a slate hip roof with glass and panel doors. It was originally constructed in 1915 and updated in 2004.
